INITIAL DAMAGE OBSERVATIONS FROM AN E-DEFENSE SHAKE TABLE TEST OF A BUILDING WITH POST-DISASTER FUNCTIONS

Trevor Z. YEOW^{*1}, Koichi KUSUNOKI^{*2}, Izumi NAKAMURA^{*3}, and Yo HIBINO^{*4}

Keywords: E-Defense, shake-table test, post-disaster functions, damage evaluation, crack observations

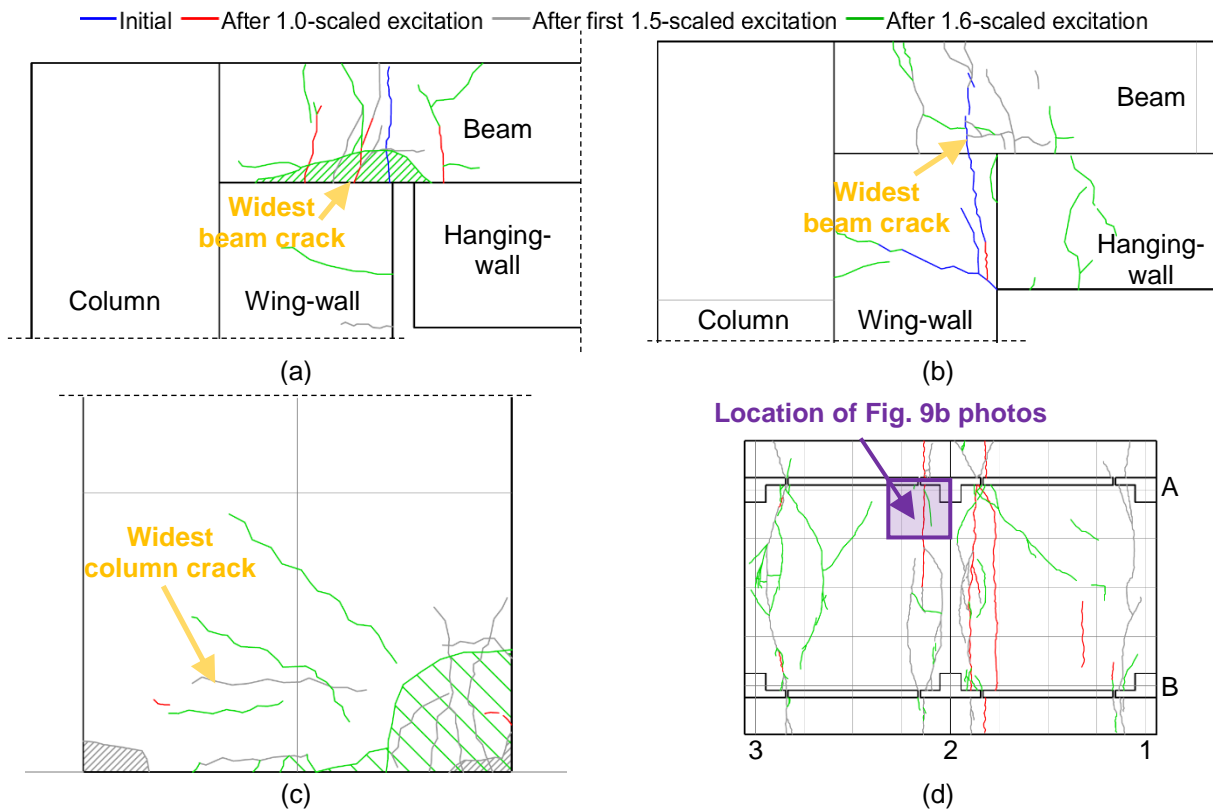
Propagation of cracks for the B1 beam-wing wall joint on 2F and 3F, the base of the A2 column on 1F, and the 3F floor slab are shown in Fig. 5; where B1 and A2 are coordinates following Fig. 1a and the location of new cracks observed after the 1.0-scaled, 1.5-scaled (first run), and 1.6-scaled events were color-coded. Damage photos for these four elements are shown in Figs. 6-9, respectively.

Fig.5 Crack patterns in various structural members; (a) 2F-B1 beam-wing wall joint, (b) 3F-B1 beam-wing wall joint, (c) 1F-A2 column base, and (d) 3F floor slab

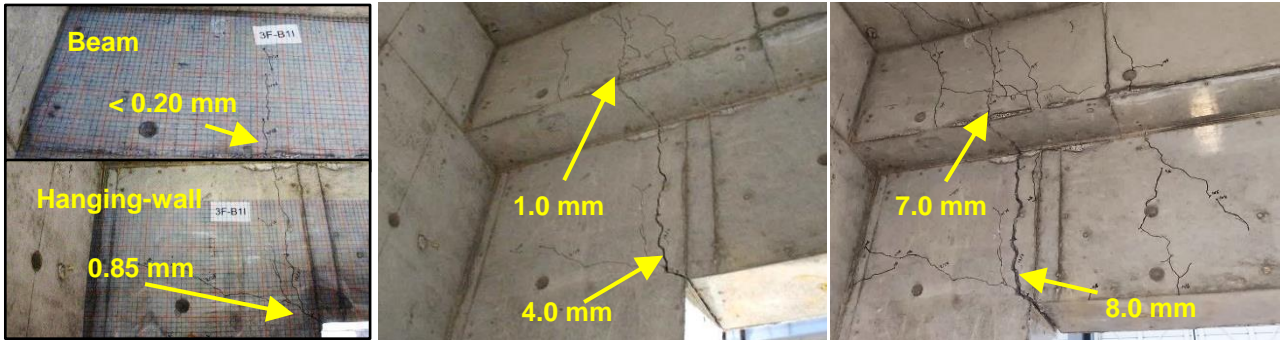
Generally, larger cracks were observed at the B1 beam-wing wall joint at 3F compared to that located at 2F. However, this large crack formed in the hanging wall where there was no reinforcing. In the beam element itself, the residual crack widths were smaller on 3F compared to 2F. Furthermore, concrete spalling was minor on 3F.

(a) After 1.0-scaled (b) After 1.5-scaled (first run) (c) After 1.6-scaled
 Fig.7 Progression of damage in 3F-B1 beam-wing wall joint (residual widths of largest crack indicated)

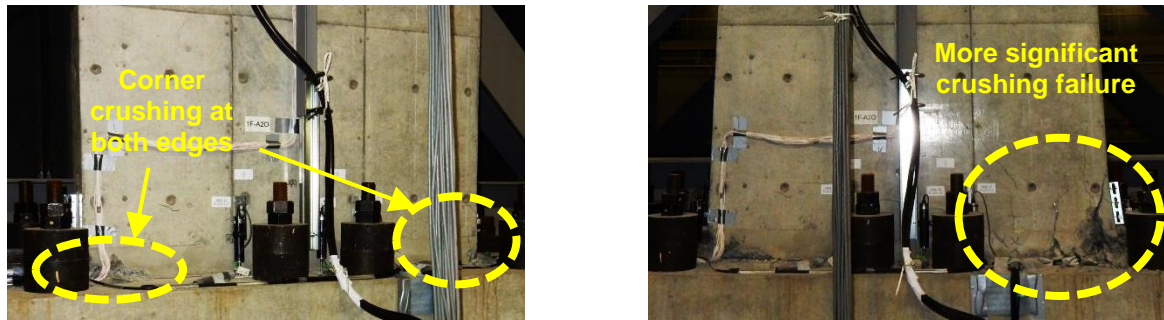
For the A2 column, most damage concentrated at the corners of the wing wall. This was expected since these portions would be subjected to high compressive strains. While some horizontal and diagonal cracks did occur in the column, the residual crack widths were generally less than 1.0 mm even after the 1.6-scaled event.

(a) After 1.5-scaled (first run) (b) After 1.6-scaled
 Fig.8 Progression of damage in 1F-A2 column base (insignificant damage observed after 1.0 scaled input and thus photo not included; significant damage indicated)

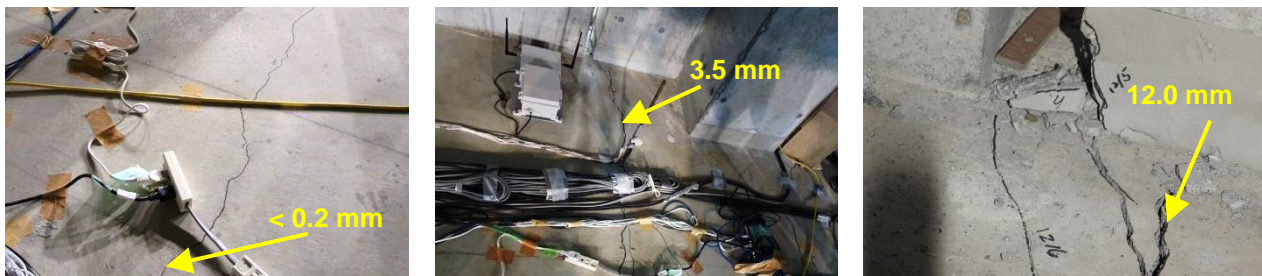
Thin cracks formed after the 1.0-scaled event on the 3F slab and originated near horizontal wall slits. The cracks eventually propagated the length of the slab, and had large residual crack widths over 10 mm after the 1.6-scaled event. Furthermore, 45° diagonal cracks started forming from the columns towards the central beam underneath the floor slab, indicating a secondary mode of force transfer due to the large cracks hindering the predominant force transfer mode.

(a) After 1.0-scaled (b) After 1.5-scaled (first run) (c) After 1.6-scaled
 Fig.9 Progression of damage in 3F floor slab (residual widths of largest crack indicated)

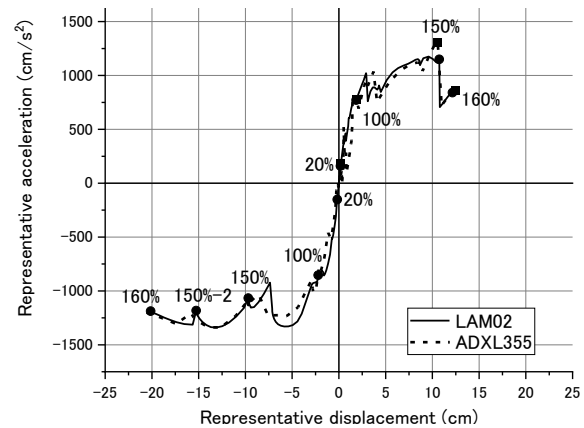
Fig. 10 Representative acceleration-displacement curve

The peak response during the 1.0-scaled event (100%) was not yet in the inelastic range, indicating slight to minor damage. After the first 1.5-scaled event (150%), the ductility response was around 2.0-3.0, indicating moderate to severe damage. Finally, significant inelastic response occurred during the 1.6-scaled event (160%), and strength decrease was observed in the positive direction, indicating severe/near collapse damage. These observations were consistent with those from visual inspections.
