STUDY OF LOW-RISE RC BUILDINGS WITH RELATIVELY HIGH SEISMIC CAPACITY DAMAGED BY GREAT EAST JAPAN EARTHQUAKE 2011

Hamood ALWASHALI*¹, Kazuki SUZUKI*¹, Kanako TAKAHASHI*¹ and Masaki MAEDA*²

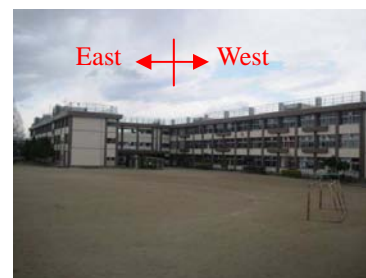
Secondly, the study of 3 storied RC building of an elementary school in Sendai city constructed in 1974 is presented (Fig.2). The building is divided by expansion joint into west side and east side. Seismic evaluation was carried out to both sides. According to the seismic evaluation, the East side building needed to be retrofitted and the West side was evaluated to have enough seismic capacity and no retrofitting was needed. The East side building, which had already seismically retrofitted suffered only minor damage in its structural members. On the other hand, the West side building was heavily damaged.

Fig.2 North view of H school building

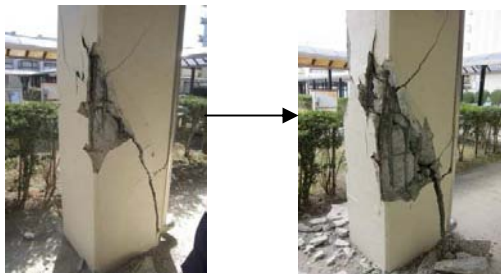
The N Lecture building had a severe shear failure in many of its columns in the 1st story in the longitudinal direction (see Fig.3). The damage to columns progressed much due to the 7th of April aftershock earthquake (see Fig.4). Less damage in the 2nd story but shear cracks were also noticed. Typical column size and its reinforcement is shown in Fig.5. First floor plan with damage classes in columns in the longitudinal direction are shown in Fig 6. Two columns were damaged by previous earthquake and strengthened by FRB sheets jacketing are marked as (? unknown) in Fig. 6. It is marked unknown because damage to concrete was invisible by the FRP jacket. The details of this repair were unavailable. However, the transverse direction was slightly damaged.

Fig.3 After 11th of March earthquake

Fig.4 After 7th of April aftershock

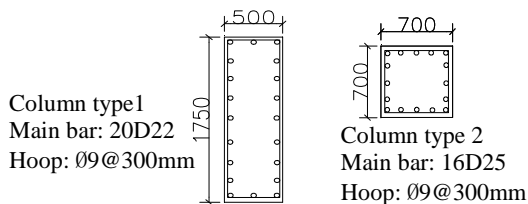
Fig.5 Typical column size and reinforcement

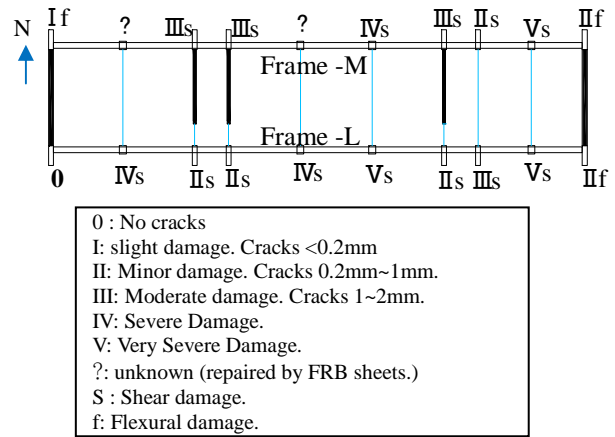
The damage levels of each column are marked with Roman numbers based on the "Post-earthquake damage evaluation standards of Japan." [2].

Fig6. 1st floor plan and damaged observed in longitudinal direction For N lecture building

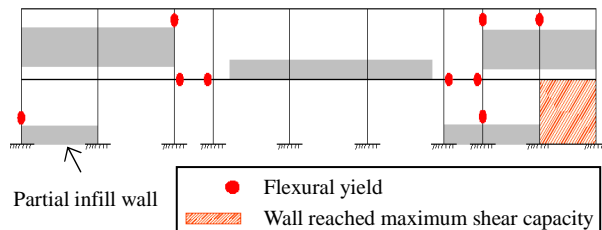
Fig. 10 shows yielded hinge locations in longitudinal direction of one frame of S lecture building at story drift of 1/200rad. The Shear wall has yielded and hinges are formed in two beams and two columns. However, as for the actual damage for S Lecture building, only shear cracks was noticed at the shear wall, no cracks was observed in other members. In the other hand, at the same story drift angle, three columns of the N Lecture building had failed in shear (Fig 11) and many columns were about to fail in shear.

Plastic hinges were expected in some beams as shown in the Fig. 10 and Fig. 11 which were not noticed in the actual damage investigation.

Fig.10 Damage predicted by pushover analysis for frame M of the S lecture at 1st story drift 0.5%

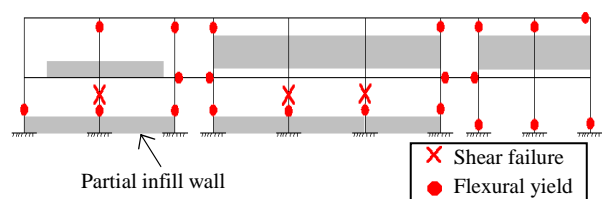
Fig.11 Damage predicted by pushover analysis for frame M of the N lecture at 1st story drift 0.5%

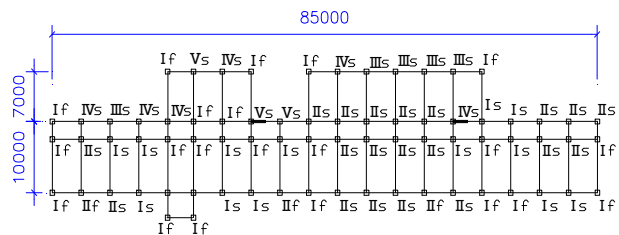
The longitudinal direction of building (W) had shear failure in many of its columns (see Fig.15) and shear cracks in wing walls (see Fig.16). Cracks in slab and beams were also observed. The transverse direction had slight damage. Damage was concentrated in the 1st floor of building (W).

Typical story plan and its damage to the longitudinal direction of building (W) are shown in Fig. 17. Typical member's size and reinforcement are shown in Fig.18

Fig17. 1st floor plan and damaged observed in longitudinal direction of building (W)

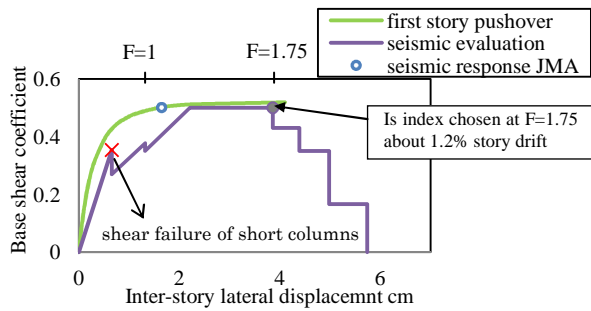
Fig23. Comparison between 1st story pushover and seismic evaluation results of building (W)

I_s index for both buildings are chosen at a ductility greater than $F=0.8$, which means that the failure of extremely short columns was allowed in the seismic evaluation, since axial loads could be redistributed to other columns and the building will not collapse. However, short column failed only in building (W) and didn't in building (E). This is due to several reasons; The $C_{TU} \cdot S_D$ for 1st story at ductility index $F = 0.8$ for building (E) is about twice of building (W), as shown in Table 5. It is thought that building (E) had a story drift just less than $F=0.8$. This is shown using seismic response of JMA NW which is just before the shear failure of short columns (see Fig. 22). Therefore short columns didn't reach their maximum allowable ductility and escaped shear failure. In the other hand, The I_s value for building (W) depends on ductility ($F=1.75$) to reach the criteria of $I_s > 0.7$. The anticipated seismic response using either JMA NW or MYG013NW spectrum are greater than $F=1$ (see Fig.23). At this seismic response, all short and shear columns had shear failure.
