- Technical Paper -

# SEISMIC DAMAGE APPROACH OF A RC RIGID-FRAME ARCH BRIDGE AFFECTED BY WENCHUAN EARTHQUAKE, 2008

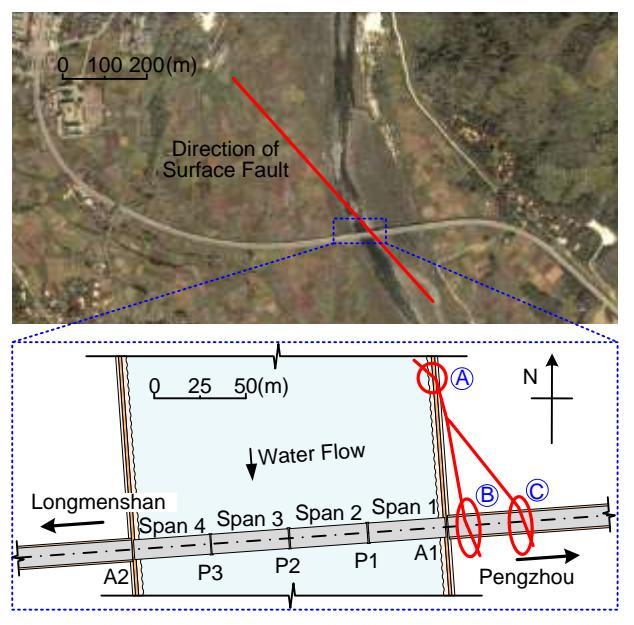
Fig.5 Surface fault around Xiaoyudong Bridge

Besides, based on Reference [5] and [1], as shown in Fig.5, a surface fault went through the right dyke at about 70m upstream (Point A). This fault displacement extended to downstream along the right dyke and crossed the road at 10m (Point B) and 50m (Point C) behind A1. On the other hand, no obvious trace of surface fault has been found at the left dyke.

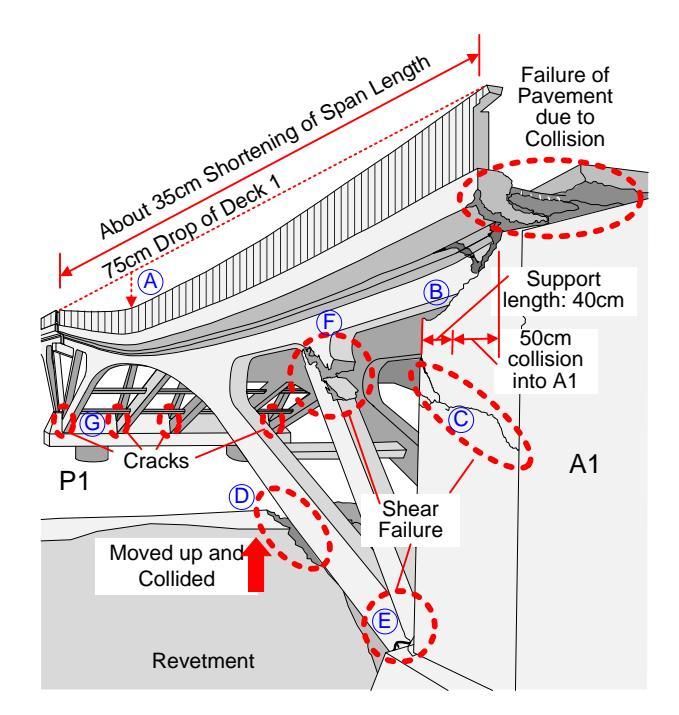
Fig.8 Damage of Span 1 (from downstream)

relative small and might not have great influence to the failure. By same procedures, the changes of span length were also got as -0.052m for Span 2, which is ignorable, and -0.347m for Span 1,. Thus, it can be inferred that, the surface fault mainly effected on Span 1.

For the detailed damage conditions, as shown in Fig.8, Span 1 moved about 75cm downwards at middle span (Point A) and there was great collision between the girder and A1 (Point B) probably due to the surface fault mentioned, which consequently caused the girder moved about 50cm into A1, and the shear failure of side wall (Point C). Because the settlement of A1, the arch legs collided with the revetment next to A1 (Point D), great shear failures occurred to the bottom of arch legs (Point E) and the top of inclined legs (Point F). Besides, some cracks occurred to the bottom of the legs (Point G) on Pier 1. For Span 2, damages are relatively slight that the middle span moved about 10cm upwards and some cracks have been observed at the bottoms of both inclined legs and arch legs. Pier 3 tilted averagely 7.5 ° toward A2 (8.08 ° from up stream, 6.85 ° from down stream of the bridge). The piles under it suffered great damage due to this tilt. Span 3 and Span 4 collapsed entirely, while the arch legs and inclined legs on them failed as well. Besides, there are shear failure on the side wall of A2, and a permanent displacement of the support about 20cm in the backsoil side.

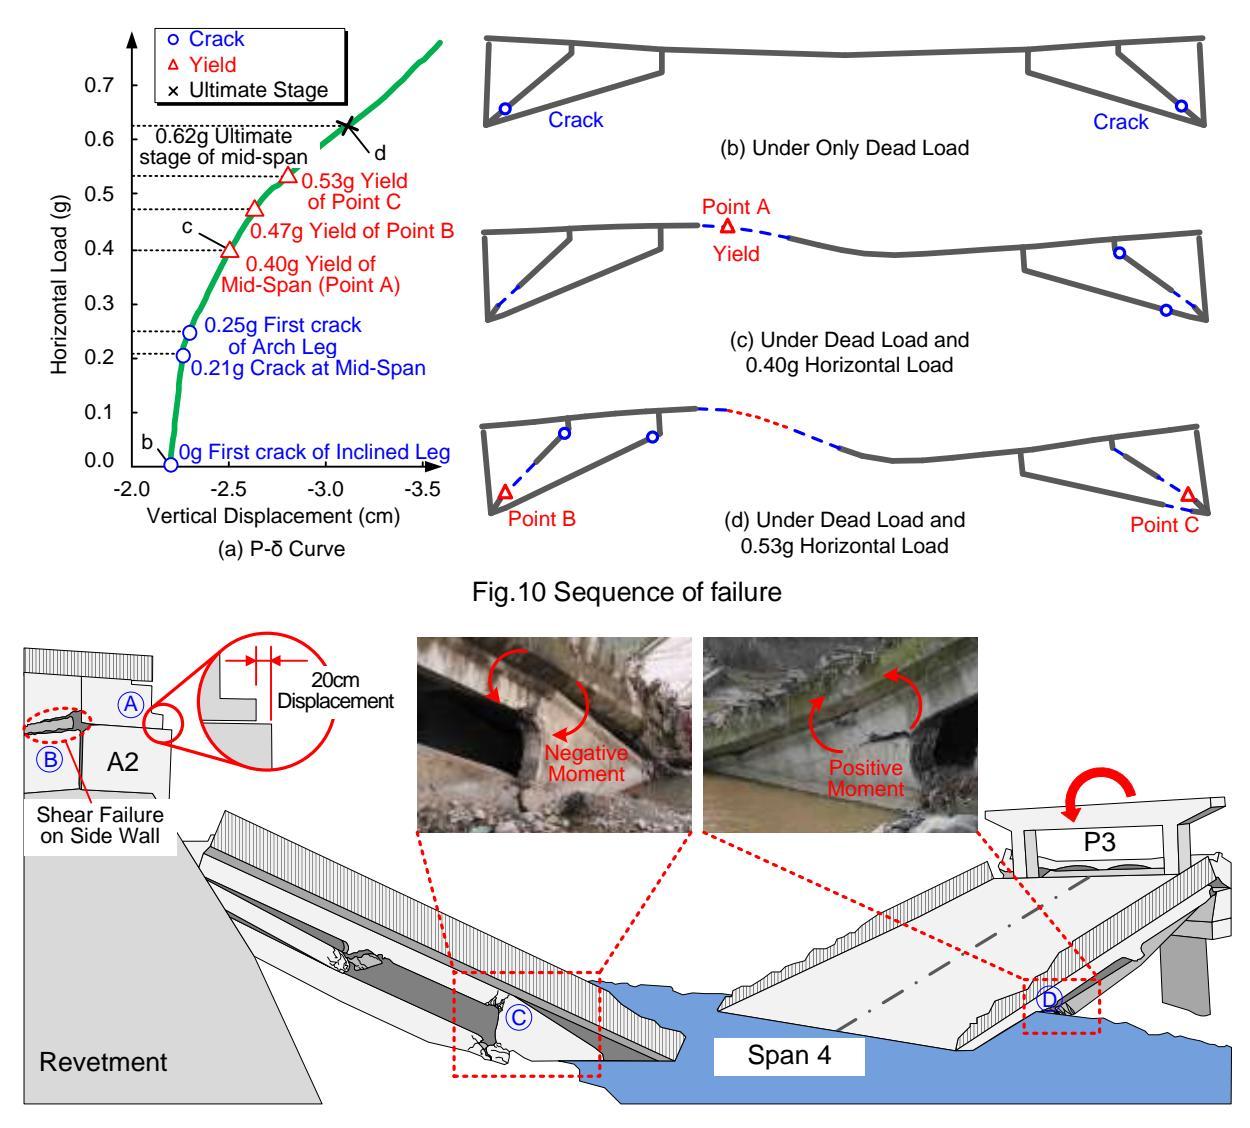
Fig.11 Detailed damage of Span 4 (from downstream)

As shown in Fig.11, for A2, there is a 20cm permanent displacement of the support into backsoil

(Point A) due to the collision between the girder and A2, and thus shear failure on the side wall (Point B). It should be noticed that at the joints of the girder and the arch legs, different types of failure occurred to left and right. On the left (see from downstream, Point C shown in Fig.11), by the negative moment, failure occurred because the reinforcement on the upside of girder resisted tension while the downside concrete resisted compression, which suggests that the girder of the left end might fell down before the failure of middle span. Differred from left, the girder on the right (Point D) was pulled by positive moment to separate from the joint, which caused the extensive crack at the joint.

Considering the phenomenon that backwards movement occurred to the support on the top of the abutment, the possibility might be great for the girder on A2 to drop down after lost the support from the abutment. Further, the difference of the joint failure between left and right also suggests the failure occurred to two sides of Span 4 at different time, that the right side (from upstream) probably drop first.

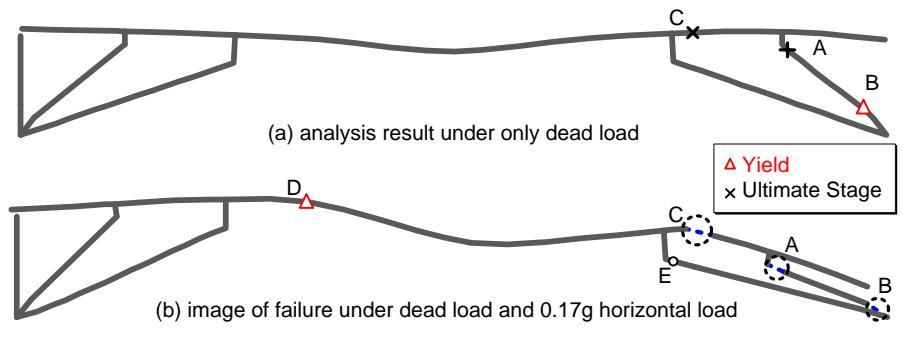
Fig.12 Sequence of failure based on approach analysis

The analytical result is explained in Fig.12. As shown in Fig.12(a), due to the loss of support, the top of the right inclined leg (Point A) and the girder next to the right joint with the arch leg (Point C) will reach their ultimate stages, while reinforcement will yield at the bottom of the right inclined leg (Point B) under only dead load. Besides, the failure will happen to the other points much earlier as well compared with that in the standard case in Chapter 3. As illustrated in Fig.13, (a) shows the responding curvature of point at the left of middle span (Point D), from which we can see that the curvature will reaches at  $\Phi_{vD}$  (yield curvature of Section D) at 0.17g horizontal load (0.40g in the standard case). Similarly, at the top of right arch leg, the curvature will reaches at  $\Phi_{vE}$  (yield curvature of Section E) under 0.59g horizontal load (no yield until 1.0g in the standard case). Because of the collision after the girder and the drop of the inclined leg at the right side, the actual failure to the right arch leg probably

occur even earlier than 0.59g. By using the definition of the bearing capacity as well, the failures of right inclined leg (Point A and B), right side of the girder (Point C) and the middle span (Point D) will cause the entire stability to lose. Therefore, the failure is likely to happen to Span 4 around 0.17g horizontal load as lost the support from the abutment, which is much earlier than the bearing capacity of 0.53g mentioned in Chap3.

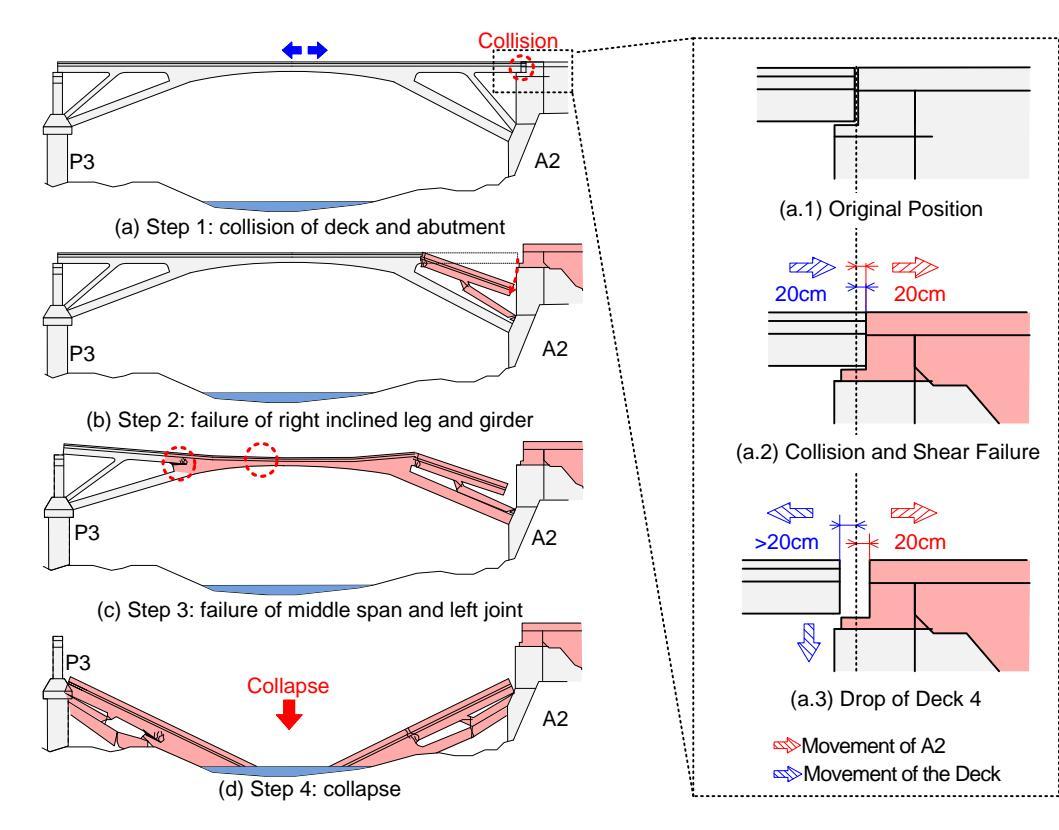
Fig.14 Failure mechanisms of Span 4 (from upstream)

According to the detailed damage condition mentioned in Chapter 4.1 and the approaching analysis conducted in Chapter 4.2, the possible failure mechanisms of Span 4 has been summarized and illustrated in Fig.14 (view from upstream).

As step 1 which is illustrated in Fig. 14(a) and details in Fig.15, the longitudinally movement of the deck of Span 4 due to the earthquake effect, as well as the movement of foundation, led to the collision between the deck of Span 4 and A2. Because of the weakness of A2 against collision, that caused the parapet and the pavement on A2 slid about 20cm into the backsoil together with the deck, and also caused the

shear failure at the side wall of A2 (shown in Fig.15(a.2)). Then, the girder moved on reversal direction. As shown in Fig.15(a.3), once the displacement of girder towards left became greater than 20cm, Span 4 lost the support from A2. Thus, based on the analytical result, the inclined legs and the girder on the right side received greater applied load, which caused the damage occurred to them (Fig.14(b)). Then, failure happened to middle span soon. Shown in Fig.14(c), as the pier and inclined leg still supported the girder on the left but failures already occurred to the right half span, the support at left and the drop at right formed greater positive moment and pulled the girder to separate from the left joint with the arch leg. Thus, the left half also failed and the entire span collapsed into the water. Consequently, Pier 3 was pushed to tilt by the force from Span 3, which caused the enormous chain failure of Span 3.
