- Technical Paper -

DAMAGE TO STRUCTURES IN RIKUZENTAKATA REGION DUE TO TSUNAMI

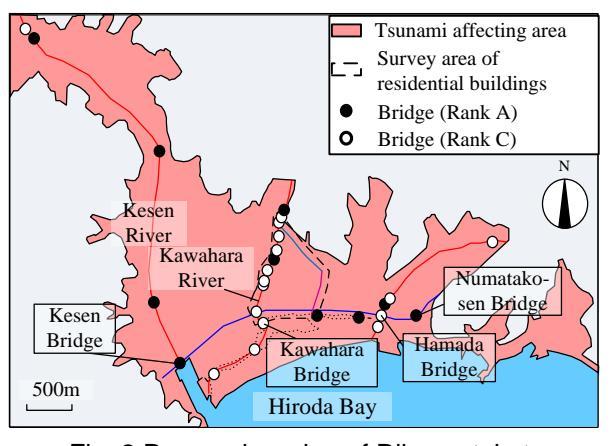
Fig. 2 Research region of Rikuzentakata

From the investigation of authors and also combined with the satellite photographs, the damage conditions of the main 26 bridges in the tsunami affecting area are evaluated, of which the results for each bridge can be referred from Fig. 2.

From Fig. 2, the authors found 80% bridges in the Kesen River suffered Rank A damage (4 in all 5 bridges); while only 18% bridges in the Kawahara River (2 in all 11 bridges). By using distance measurement function of Google Earth, Kensen River has greater size (width in level of 120m) than Kawahara River (width in level of 15m). Direct run-up of tsunami in the greater size river is considered as the reason for more serious damages of related bridges.

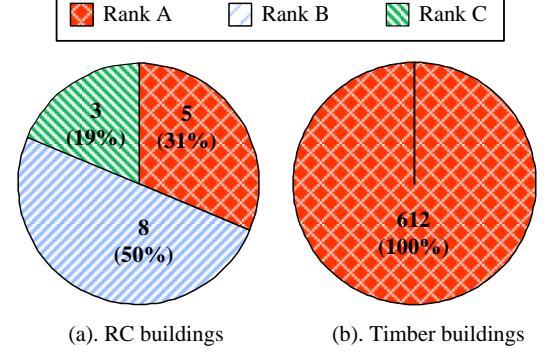
Fig. 3 Investigation result of buildings

Authors defined the damage extents of residential buildings as presented in Table 1. In Fig. 3, among total 16 RC buildings, proportion is 31%, 50% and 19% for Rank A, B and C, respectively. 70% of RC buildings suffered non-structural damage (sum of Rank B and C buildings), which suggests the great resistance to tsunami impact. Further, all 612 timber buildings are washed away or crashed into pieces by tsunami effect (Rank A), from which, timber building is considered not suitable for future design of anti-tsunami building.

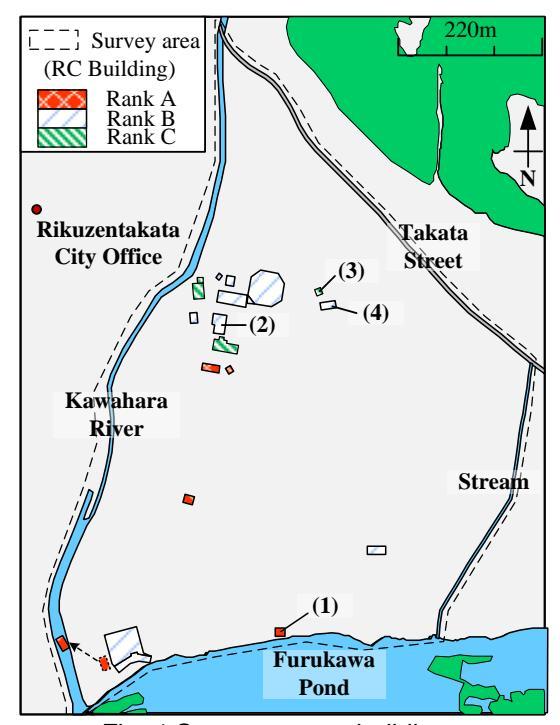
Fig. 4 Survey area to buildings

Fig. 4 presents the distributions of RC buildings in survey area. Compared with Rank B and Rank C buildings, there is the trend that Rank A buildings are relatively in smaller size which makes the building with smaller strength to resist tsunami impact. Further, Rank A buildings are mainly distributing in regions relatively closer to the coastline.

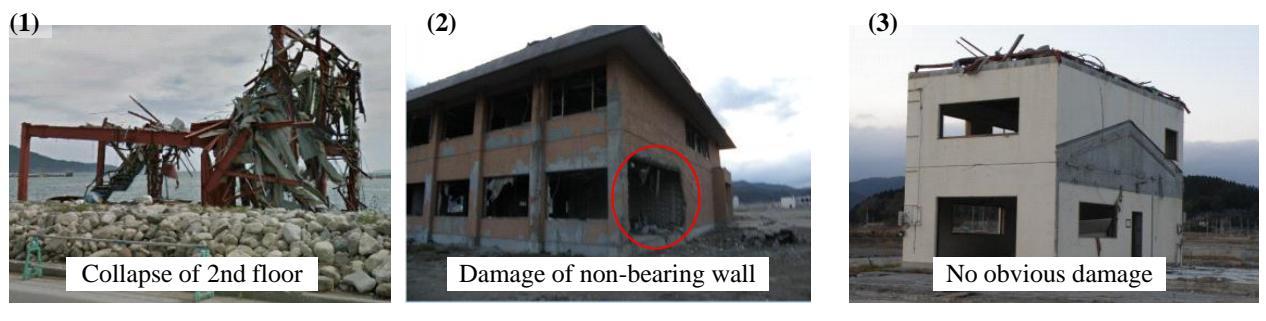
To introduce the detailed damage performances of RC buildings, one typical building is selected for each damage rank with their photos shown in Fig. 5. Positions can be referred from Fig. 4. Typical Rank A building is a two-floor, steel-frame structure with its structural members seriously damaged. Bearing columns of left side in second floor were washed away and beams in horizontal direction suffered seriously flexural damage and gathered to residual frame at right side; side walls of it have all been washed away; Typical Rank B building is a reinforced concrete building with its non-bearing wall in the first floor damaged; great lateral load of tsunami impact probably caused it; typical Rank C building (building (3)) is also a reinforced concrete building with relatively smaller

Rank B Fig. 5 Damage performance of buildings

size. Since building (4) (Fig. 4) with greater size in front of it worked as barrier and weakened the impact, building (3) did not suffer great damage.

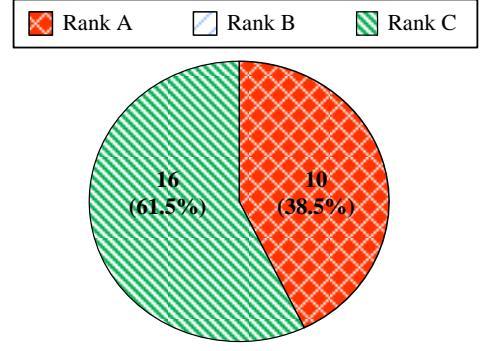
Fig. 6 Investigation result of bridges

As illustrated in Fig. 6, the damage conditions for the surveyed bridges are apparently divided into Rank A and Rank C, with Rank A taking the share of around 39% (10 among all the 26 bridges) while Rank C taking the share of around 62% (16 among all 26 bridges).
