- Technical Paper -

DAMAGE TO STRUCTURES DUE TO TSUNAMI AND EVALUATION OF TSUNAMI VELOCITY IN SHIZUGAWA

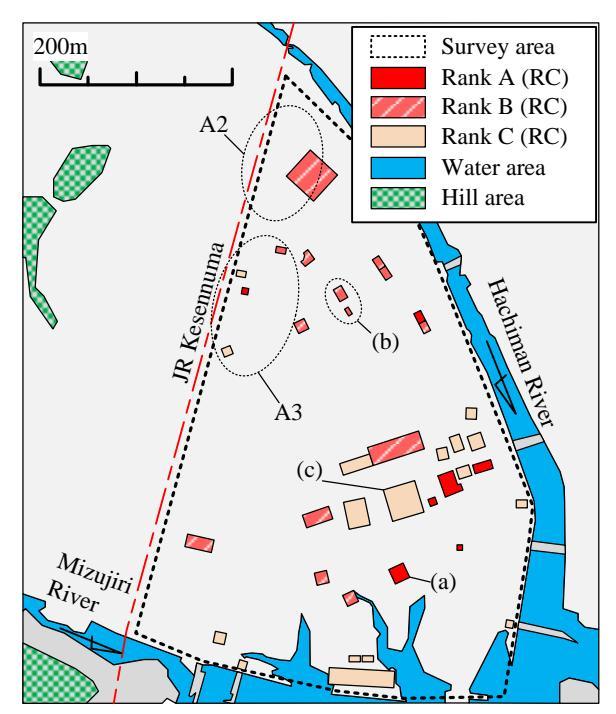
Fig. 4 Investigation area of buildings

After classification of damage, the statistical damage result is obtained. In the building survey area, originally 492 buildings had been built. Among them, there are 39 RC buildings totally, the scales and locations of which could be checked in Fig. 4. The proportion of each rank is plotted in Fig. 5-(a). Obviously about 18% RC buildings experienced structural damage of Rank A. Besides that, it is noted that compared to the buildings of Rank B and C, the buildings of Rank A have relatively smaller size. For the damage to timber building, it was more devastating than RC buildings and all of timber buildings were washed away or crashed into pieces (Fig. 5-(b)).

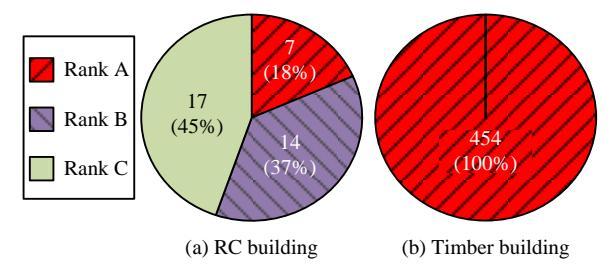
Fig. 5 Investigation result of buildings

From the investigation result, it is known that most main structures of RC buildings could withstand the tsunami effect, while all the timber buildings are destroyed completely.

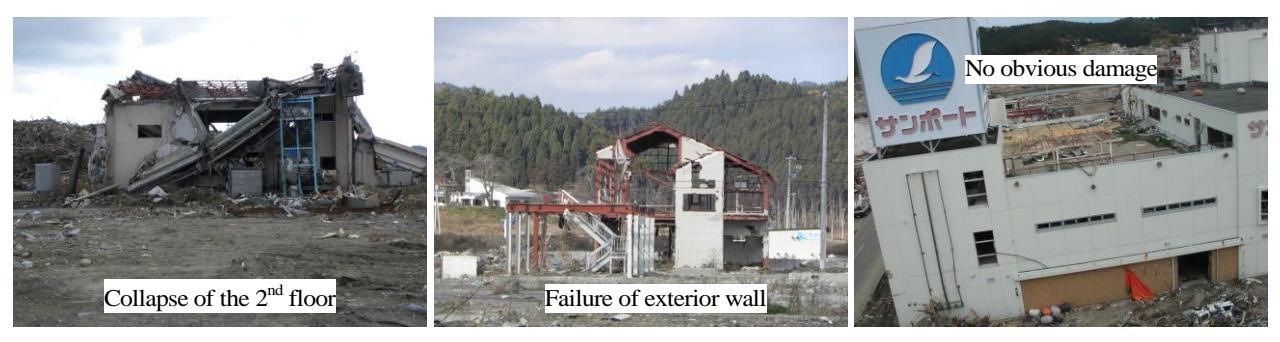
(b) Rank B Fig. 3 Damage performance of buildings

The Rank A building (Fig. 3-(a)) is a 2-story, steel-frame reinforced concrete structure. After the tsunami surge, a devastating structural damage occurred to it. The second floor collapsed completely.

Fig. 3-(b) illustrates the damage to Rank B building. The exterior walls and non-structural steel-frames of 2 buildings were washed away or bend while the structural steel-frames still stand, which is a serious non-structural damage.

Fig. 3-(c) shows the performance of Rank C building which has a large scale. It withstood the tsunami effect and only experienced the damage to doors and windows. Compared to the Rank B buildings, its concrete wall contains adequate strength against tsunami load.

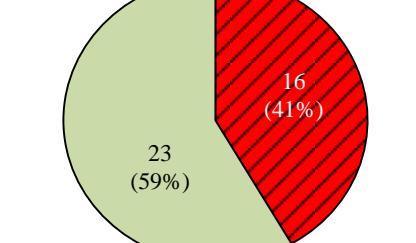
Fig. 6 Investigation result of bridges

As a result, for the superstructures of the 39 bridges, 41% flowed out and belong to Rank A, as illustrated in Fig. 6. Further, all the superstructures of Rank A bridges are confirmed to flow out to the upstream direction.

In addition, compared to other tsunami affecting areas in Shizugawa, the inland Area 1 (Fig. 2), is farther to coastal line (around 1.3km), so the tsunami energy in Area 1 was weaker, due to ground friction. However, on the contrary, among the 16 bridges in Area 1, 9 bridges belong to Rank A, namely the damage in Area 1 is more serious. Therefore, it is concluded that even if for the bridges in farther inland, they are possible to be seriously affected by tsunami as well.

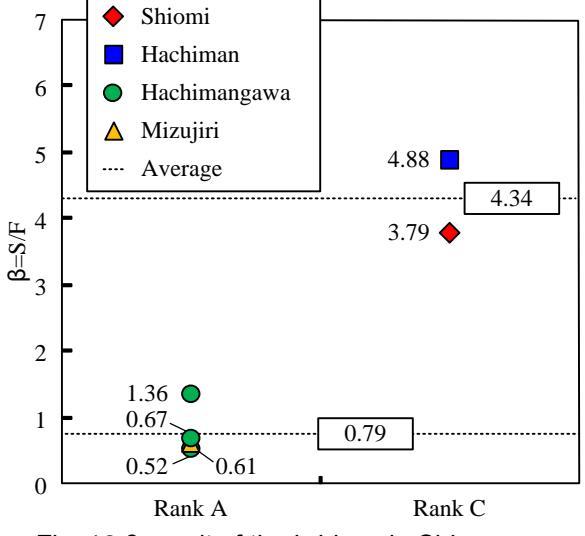
Fig. 12 β result of the bridges in Shizugawa

The β result of 4 bridges is illustrated in Fig. 12. It is notable that the β of 2 damage ranks have different levels. Most of the superstructures of Rank A give the β smaller than 1.0, except for S4 of Hachimangawa Bridge. The average β of Rank C gives a great value which is about 5.5 times as great as Rank A. Besides, compared with that, the 18 bridges damaged by tsunami induced by Sumatra Earthquake have been analyzed by using β , and the average β of Rank C is about 2.8 times as great as Rank A (Rank A: 0.8, Rank C: 2.2)^[4]. Therefore, it indicates β is effective to evaluate the outflow condition of bridge superstructure.
