INFLUENCE OF JOINT POSITION ON SHEAR BEHAVIOR OF SEGMENTAL CONCRETE BEAMS WITH EXTERNAL TENDONS

Dinh Hung NGUYEN^{*1}, Junichiro NIWA^{*2}, Chunyakom SIVALEEPUNTH^{*3} and Tsuyoshi HASEGAWA^{*4}

ABSTRACT

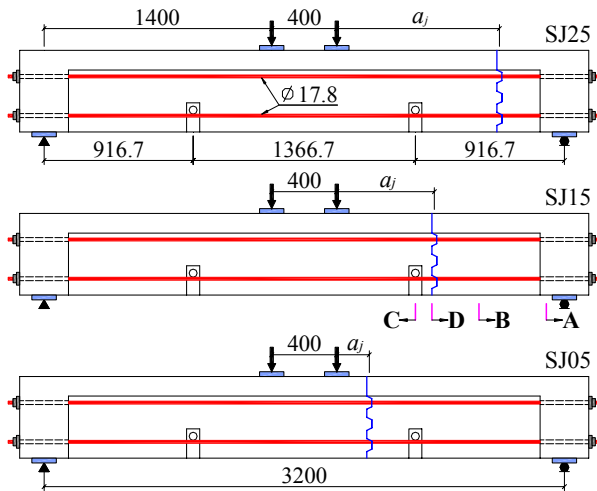
(a) General view

Fig. 1 Detail of test beams

The prestressing tendon used for the beams was of type SWPR19L Φ 17.8 mm. Yielding and ultimate strengths of the tendon are 1680 N/mm² and 1900 N/mm², respectively. The external tendons were applied in both tensile zone (lower tendons) and compressive zone (upper tendons) as shown in Fig. 1(a) and were stretched 4 days before testing. At the prestressing stage, the pair of the upper or lower tendons was stretched at the same time from one end by two hydraulic jacks. It has been noted that the higher prestressing force is, the narrower joint opening is. Moreover, it was ensured the whole joint suffers compression and the beam failure occurs in concrete before the yielding of the external tendons. Therefore, the amount of initial prestressing force for upper and lower tendons was approximately 31% and 41% of the ultimate strength of the tendons, f_{pu} , respectively. The actual effective prestress of the tendons is shown in Table 4. Steel deviators were attached to the beams from the bottom to ensure not

The beams were subjected to a four point loading with a distance of 400 mm between the loading points, as shown in Fig. 1. The load was increased monotonically by the displacement control method until the beam reached the final failure.

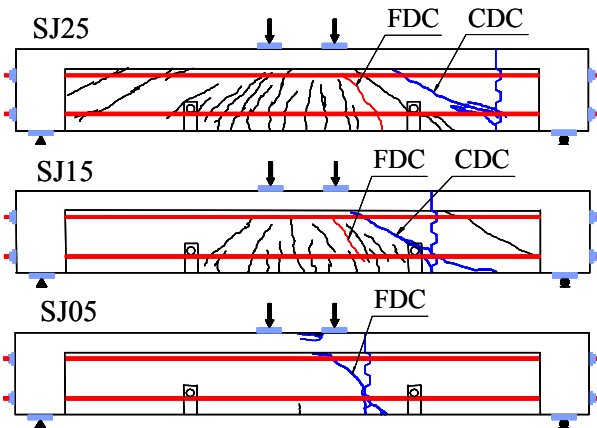
Fig.2 Crack patterns

Note:
 FDC: The first diagonal crack
 CDC: The critical diagonal crack

The crack patterns of the specimens are shown in Fig. 2. It was observed that the all tested beams, the crack patterns were found to be different. The first flexural crack of all beams occurred in the tensile zone between the two loading points as shown in Fig. 2.

For the beam SJ05, after the first flexural crack formed, a first diagonal crack, also the final diagonal crack occurred in the web from the loading point to the lower key zone at an applied load of 327.7 kN as shown in Fig. 2. When the load increased, the width of the diagonal crack increased rapidly. The diagonal crack was propagated along the region between the web and the flange until crushing occurred in the flange near the loading point on the test span as shown in Fig. 3. As the final diagonal crack was propagated to the lower

For the beams SJ15 and SJ25, a number of flexural cracks increased and then the first diagonal crack occurred in the shear span between the two deviators in Fig. 2 when the applied load increased. From Table 5, it can be seen that the first diagonal crack of these beams occurred at similar loads. This means that the joint position has no effect on the occurrence of the first diagonal crack. The difference appeared after the first diagonal crack was formed. A number of diagonal cracks continuously increased mainly in the interval between the two deviators. The cracks did not open very wide, therefore, the shear strength became larger.

The crack patterns of all segmental concrete beams prestressed with external tendons are shown in Fig. 2. It can be said that the failure of the beams was different depending on the joint position. The epoxy joint position influenced not only the slope and the load of the critical diagonal crack but also on the failure mechanism of the beams. In segmental concrete beams prestressed with external tendons on the other hand, the critical crack depends on the joint position as discussed in the section 3.1. The cracks determine how the arch and beam mechanisms carry the shear force and are fundamental part of shear failure [7].
