AN EXPERIMENTAL STUDY OF REINFORCED CONCRETE BEAMS STRENGTHENED WITH INTERNAL PBO FIBER MESHES IN SHEAR

ABSTRACT

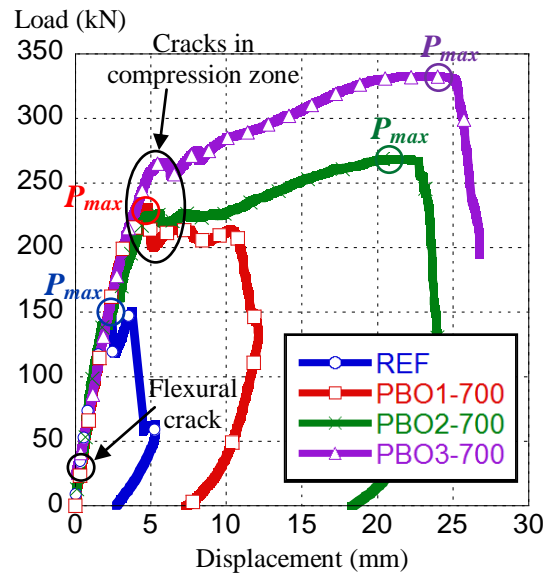
Fig. 7 Load-displacement curves in series I

The load-displacement curves of the tested specimens in series I are illustrated in Fig. 7 and in

For the REF beam shown in a blue line in Figs. 7 and 8, the beam exhibited a linear behavior prior to the presence of the first flexural crack when the load reached about 30 kN. After that, several small flexural cracks appeared close to the mid span of the concrete surface leading to a small inclination of the curve. The load continually increased until it reached the peak load at 155.68 kN and a clear big diagonal crack was observed around the middle height of the specimen at this state. The failure mode of this reference beam can be distinctly explained as a diagonal tension failure.

After the cracks in the compression zone happened, multiple visible cracks were observed in the shear span and the progression of the load was significantly slow with a much extension of the deflection especially in PBO2-700 and PBO3-700, which can be seen explicitly in Fig. 7. Finally, the diagonal crack and cracks in the compression zone became dangerously wider and the sound of rupture of the meshes could be heard before the load reached their peak load as displayed in Fig. 9(c).

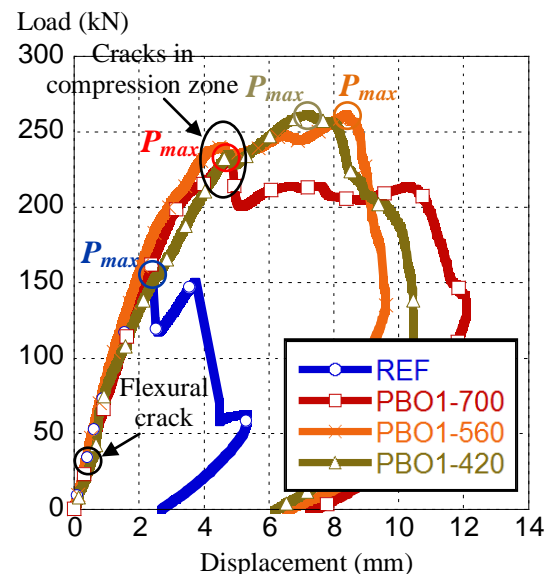
Fig. 8 Load-displacement curves in series II

case of series II are illustrated in Fig. 8. The difference in displacement at the peak load of each specimen was revealed in series I. However, the difference in displacements of the strengthened specimens at the peak load in series II was much smaller than series I as the number of layer of the strengthened PBO fiber meshes was same.

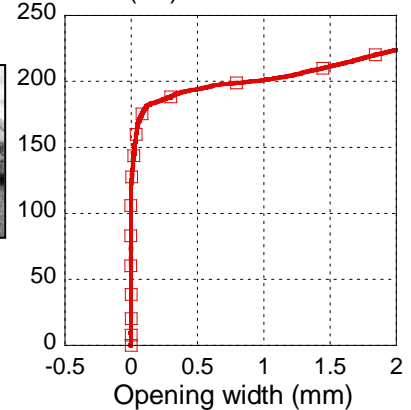
Fig. 10 Load-opening width at the middle height of shear span of PBO2-700

As mentioned before, all the strengthened beams behaved linear manner during the initial state of the loading. After the diagonal crack occurred at the middle height of the shear span, the load kept increasing mainly because of the tensile force from the internal PBO fiber meshes which was embracing the inner portion of the beams. After that, because of the extension of the meshes, the expansion of the main diagonal crack became wider in the next state prior to the presence of cracks in the compression zone.

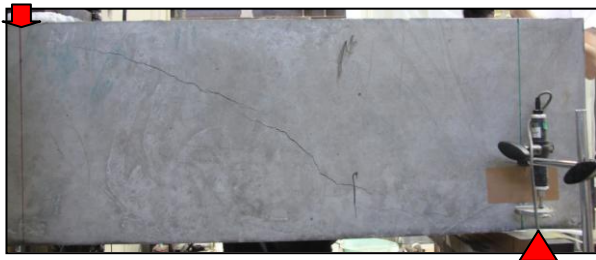
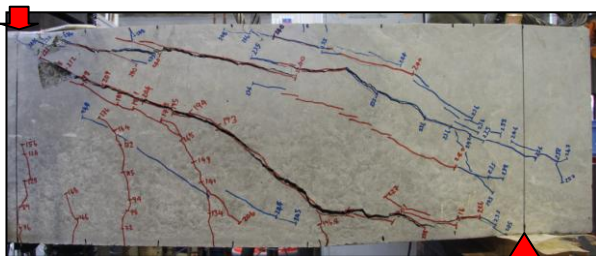
Fig. 11 Crack patterns (at peak load)

After the occurrence of cracks in the compression zone, the shear force was still increasing with a very small inclination of the load-displacement curve. During this state, only the internal PBO fiber meshes and the core concrete were expected to carry the shear force until the load reached the peak. The picture of the PBO2-700 after loading test can be seen as shown in Fig. 9(e). Figure 11 shows the crack patterns for all tested specimens at the peak load. It can be seen that the effect of cracks in the compression zone had occurred in all strengthened specimens.
