# 論文 EXPERIMENTS ON THE BEHAVIOR OF POST-TENSIONED CONCRETE BEAMS DETERIORATED BY CORROSION

Ha MINH\*<sup>1</sup>, Hiroshi MUTSUYOSHI\*<sup>2</sup>, Hirotsugu TANIGUCHI\*<sup>3</sup>  
and Kyoji NIITANI\*<sup>4</sup>

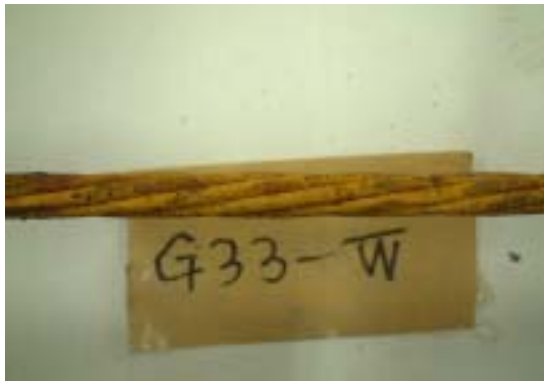
Fig.3 Corrosion of prestressing steel (Beam B8)

**Fig.3** shows the picture of corrosion of prestressing steel for the beam B8 (G33-W-P60) and **Fig.4** shows the failure of the beam B7 (G0-W-P60). **Table 3** shows the result of accelerated corrosion test. The relationships between corrosion potential and applied current time for all beams are shown in **Fig.5** and **Fig.6**. Corrosion of the sheaths and prestressing tendons occurred in all beams (except beam B2). The rust was observed in the sheaths and prestressing steel for all beams (except beam B2) and the measuring corrosion potentials for those beams were more negative than  $-450$  mV CSE. No corrosion occurred in the sheath and prestressing tendon for the beam B2 because no sodium chloride solution was mixed in the concrete. It is confirmed that the experimental methodology presented in this study is very effective to predict the corrosion of the sheaths and prestressing steel. **Fig.7** shows the reduction of stress in tendon for the beams with and without applying water. The reductions of stress in tendons for the beams B8 and B9 (filled up water in the duct) were faster than those of the beams B4 and B5 (without water). It shows that the tendon stress reduces with the increase of water in the ducts, which might be due to the acceleration of corrosion process of prestressing steel. **Fig.8** shows the average of crack width for the beams B4, B5 and B6. This figure shows that the crack width of the beams increases with the increasing grout-filling level. When the sheaths and prestressing steel corroded, the volume of the corrosion product became 2.5 to 3 times of the original volume of steel. Due to the increase in the volume, radial pressure was developed in the surrounding grout and concrete resulting cracks in concrete. Therefore the crack width of the beams increases with the increasing grout-filling level in the sheaths.

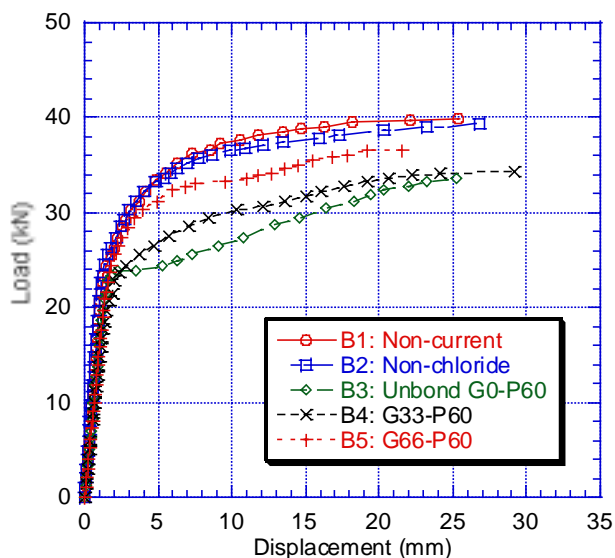
Fig. 9 Load-displacement (B1-B5)

The result of loading test is shown in **Table 4**. **Fig.9** and **Fig.10** show the load-displacement relationship for all test beams. All the beams failed in flexure and crushing of concrete occurred finally in the compression zone. The control beam B1 failed at the load of 40 kN. The beam B2 failed at almost the same load level since no corrosion occurred in the sheaths and prestressing steel of this beam. The failure load of the beam B6 (G100-P60) was lower than that of the control beam B1. It is confirmed that the corrosion of prestressing steel caused the decrease of loading capacity of post-tensioned concrete beams. The failure loads of the beams B7 (G0-W-P60), B8 (G33-W-P60), B9 (G66-W-P60) were lower than those of the beams B3 (G0-P60), B4 (G33-P60), B5 (G66-P60) respectively. It shows that the water filled in the sheaths caused the reduction of loading capacity of post-tensioned concrete beams.
