- Technical Paper -

# SEISMIC DAMAGE APPROACH OF A RC RIGID-FRAME ARCH BRIDGE AFFECTED BY WENCHUAN EARTHQUAKE, 2008

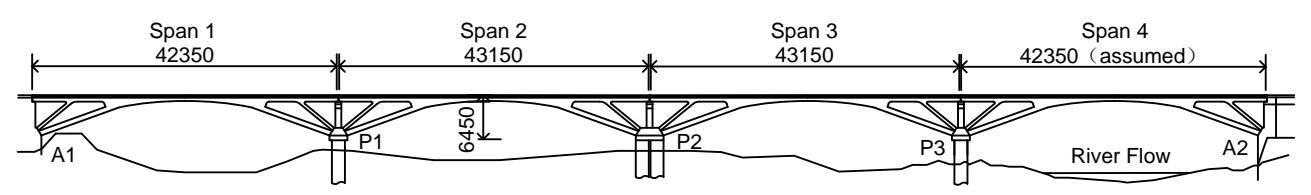
Fig.2 Assumed length of spans before the earthquake based on the survey (unit: mm, from upstream)

abutments, piers and spans were numbered from the left bank. Based on the data measured by measuring tape, Span 1 has a length of 42.35m, while Span 2 and 3 have the same length of 43.15m. Thus, considering the same length of Span 2 and 3, and no geographical limitation for piers and abutments, four spans are assumed to be symmetrical. As the river went through Span 4, and the girder collapsed into water, it was impossible to measure the girder of Span 4. Noticing the symmetry of the entire bridge, the length of Span 4 was assumed as same as Span 1 of 42.35m. The details of Span2 as examples are illustrated in Fig.3 that the arch leg (Point A) and the inclined leg (Point B) has 21° and 40° slope respectively. The arch frame is formed by two arch legs from the pile caps, and the girder in the middle span. This arch frame composes one single rigid-frame, together with two inclined legs, and the girders (Point C) at ends of deck. One span consists of five rigid-frames connected by crossing beam (Point D), arch slab (Point E), and extending slab (Point F). Four spans are supported by rubber bearings and connected by piers abutments. A pier consists of a reinforced concrete frame with two columns and a beam, upon which two decks were simply supported. The legs were connected to the pile cap supported by reinforced concrete piles.

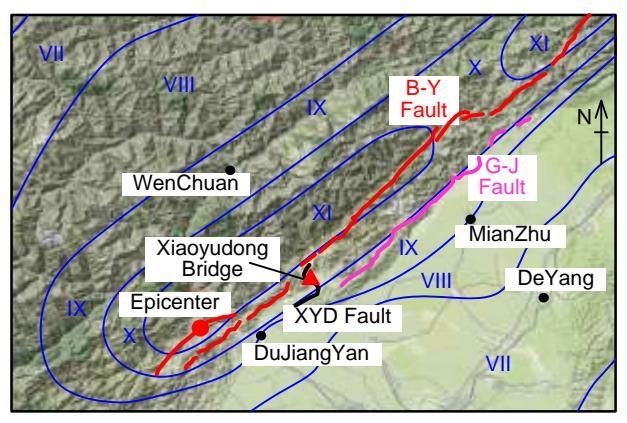
Fig.4 Intensity scale and surface faults

According to Reference [4], there are two main surface faults after the earthquake: Beichuan-Yingxiu Fault (B-Y Fault in Fig.4), Guanxian-Jiangyou Fault (G-J Fault). Another fault named Xiaoyudong Fault (XYD Fault) connected these main two. Our object bridge Xiaoyudong Bridge (the triangle in Fig.4) is located between that two main surface faults and on this connecting Xiaoyudong Fault.

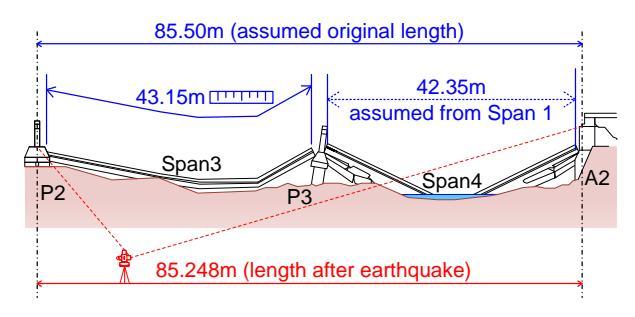
Fig.7 Method of measuring

To confirm the influence of the surface faults, detailed field survey of the span length has been done by using both the electrical total station and the measuring tape (shown in Fig.6). The method is illustrated in Fig.7. We measured the length of Span 3 as 43.15m by measuring tape and assumed the length of Span 4 as 42.35m as mentioned in Chapter 2.1. Thus, the original distance between P2 and A2 (length of Span 3 and 4) before the earthquake was predicted as 85.50m. On the other hand, the actual distance between P2 and A2 was observed again by using electrical total station. Therefore, the change of span length was got as -0.252m (=85.248- 85.500). Thus, the average length change of Span 3 and 4 is about 12.6cm, which is

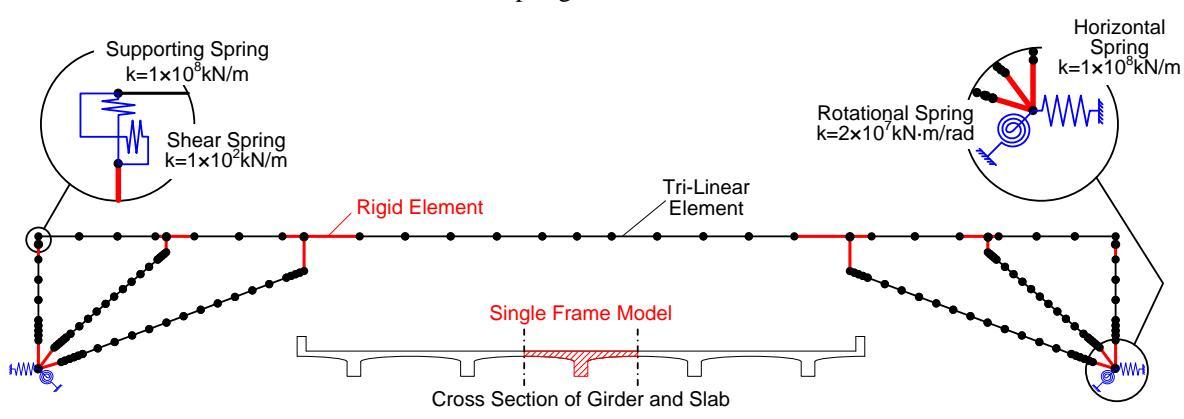
Fig.9 Model for single span

The model has been made for Span 2 where damage was few, to evaluate the bearing capacity (using the definition that failure to less than three parts on the rigid-frame arch). As shown in Fig.9, on the transversal direction of the bridge, noticing five arch frames were arranged together to form one span, here select one single arch frame, included the arch slab, to establish the 2-dimensional model. A horizontal spring
