- Technical Paper -

DAMAGE TO STRUCTURES IN RIKUZENTAKATA REGION DUE TO TSUNAMI

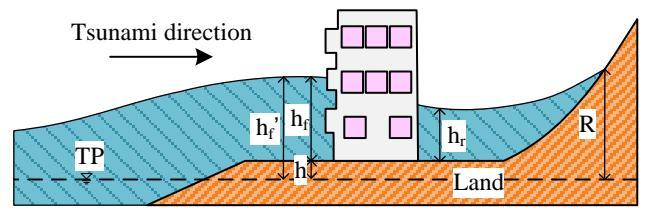
Fig. 9 Factors for equation

Where *u* is the tsunami velocity; h_f and h_r are the inundation depth in front and behind of the building, respectively; *R* is the tsunami run-up height; C_v is the velocity coefficient; F_r is the Froude number; *g* is the gravity acceleration (9.8m/s²). Some of the parameters are illustrated in Fig. 9.

As illustrated in Fig. 9, h_f ' is the inundation elevation (front of building, from TP level). *h* is ground height (ground settlement by earthquake included, from TP level). Values of these two parameters can be obtained based on reference ^[6]. Thus, based on the inundation depth h_f (difference of h_f ' and h), velocities

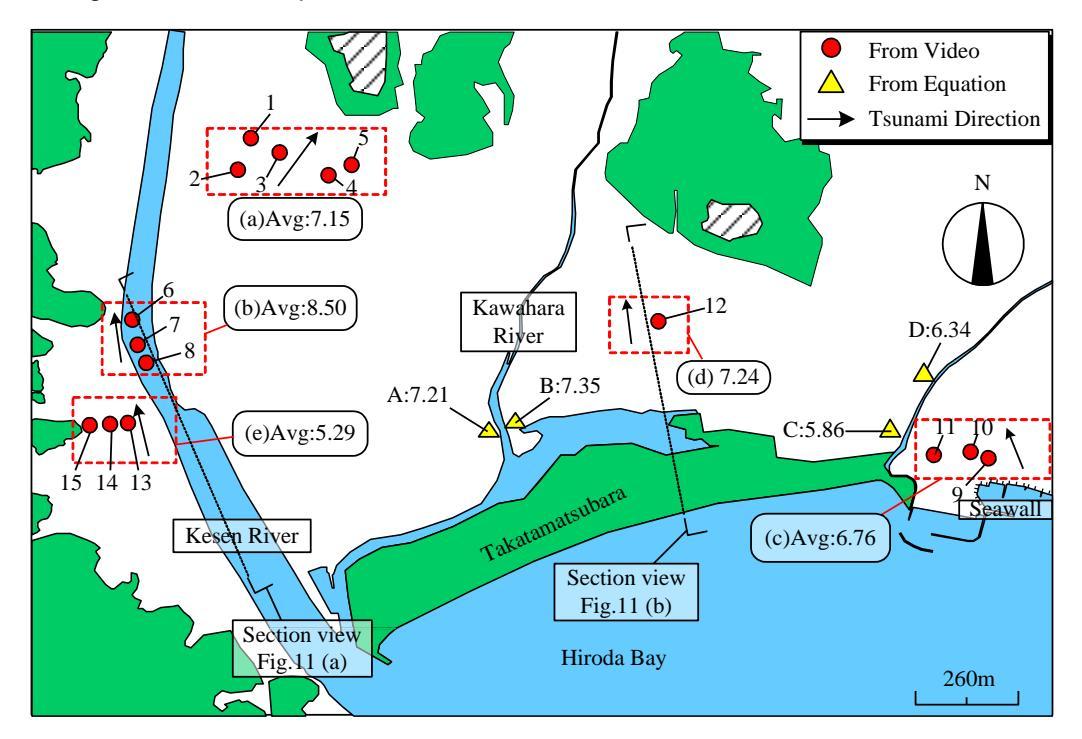
Fig. 10 Distribution of tsunami velocity

The evaluation positions are plotted in Fig. 10. Table 4 presents calculation parameters for total 15 groups of evaluated velocities. Average values of each sub-area are in the range from 5.29m/s to 8.50m/s; (b) area has relatively greater velocity than others, of which the reason will be analyzed in next section.

near four buildings (positions shown in Fig. 10) can be calculated from Eq. 6. Table 5 shows calculation parameters and results. From Fig. 10, evaluated tsunami velocities from equation can roughly coincide with those in neighboring areas from videos. (A B with (d), C D with (c), Fig. 10)

Tsunami velocity in river area ((b), 8.50m/s, Fig. 10) is 29% greater than land area (avg of each avg velocity in (a), (c), (d) and (e), 6.61m/s, Fig. 10). From reference^[7], tsunami energy can be partly weakened by friction effect of land and plants. Further, based on video screens and relative height differences between tsunami surface with buildings (No.1, 2 building, Fig. 11) and bridges (No.3, 4 bridge, Fig. 11), sketching of wave shapes for the front part of tsunami can be drawn as shown in Fig. 11 with sectional positions referred from Fig. 10. It is confirmed that except wavefront part, entire tsunami is in shape without great variation of height for both river and land area. Since slope angle of wavefront for river area is around 90° (A, Fig. 11 (a)) and based on wave shape, wave of river area is considered as Breaker Bore, with greater energy and velocity^[8]. As for land area, slope angle (around 9°, B, Fig. 11 (b)) is relatively small, inducing the smaller energy and velocity.

Thus, focus on evaluated results from videos as illustrated in Table 4 and Fig. 10, the average tsunami velocity for Rikuzentakata is about 7.0m/s, being greater than 6.0m/s of entire Tohoku area (Chap. 3).
