INITIAL DAMAGE OBSERVATIONS FROM AN E-DEFENSE SHAKE TABLE TEST OF A BUILDING WITH POST-DISASTER FUNCTIONS

Trevor Z. YEOW^{*1}, Koichi KUSUNOKI^{*2}, Izumi NAKAMURA^{*3}, and Yo HIBINO^{*4}

Keywords: E-Defense, shake-table test, post-disaster functions, damage evaluation, crack observations

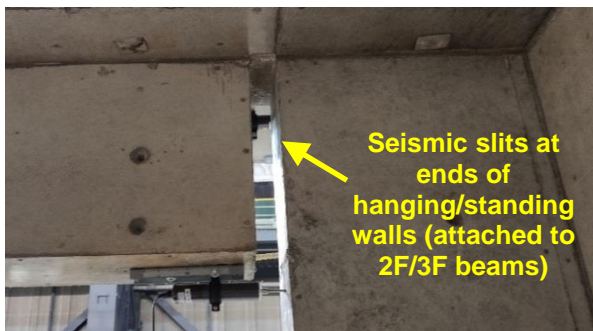
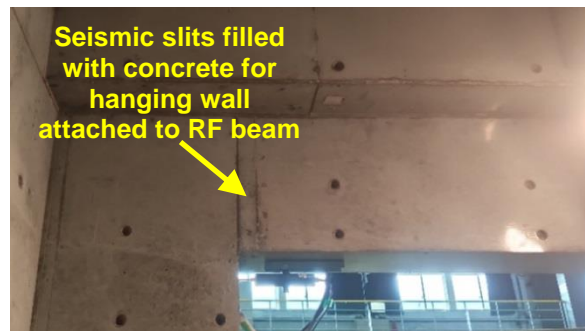
Cladding wall elements were casted to be monolithic with frame elements parallel to the shaking-direction, as shown in Fig. 2. Slits with 50 mm width were present at the ends of horizontal walls on 2F and 3F (Fig. 2a), while the slits at RF and column bases was filled with concrete (Fig. 2b).

Fig.2 Detailing at hanging/standing walls ends, (a) 50 mm gap at ends of hanging/standing walls attached to 2F/3F beams, and (b) concrete filled gap on roof level beams (wall longitudinal reinforcing terminated)
