- Technical Paper -

DAMAGE TO STRUCTURES DUE TO TSUNAMI AND EVALUATION OF TSUNAMI VELOCITY IN SHIZUGAWA

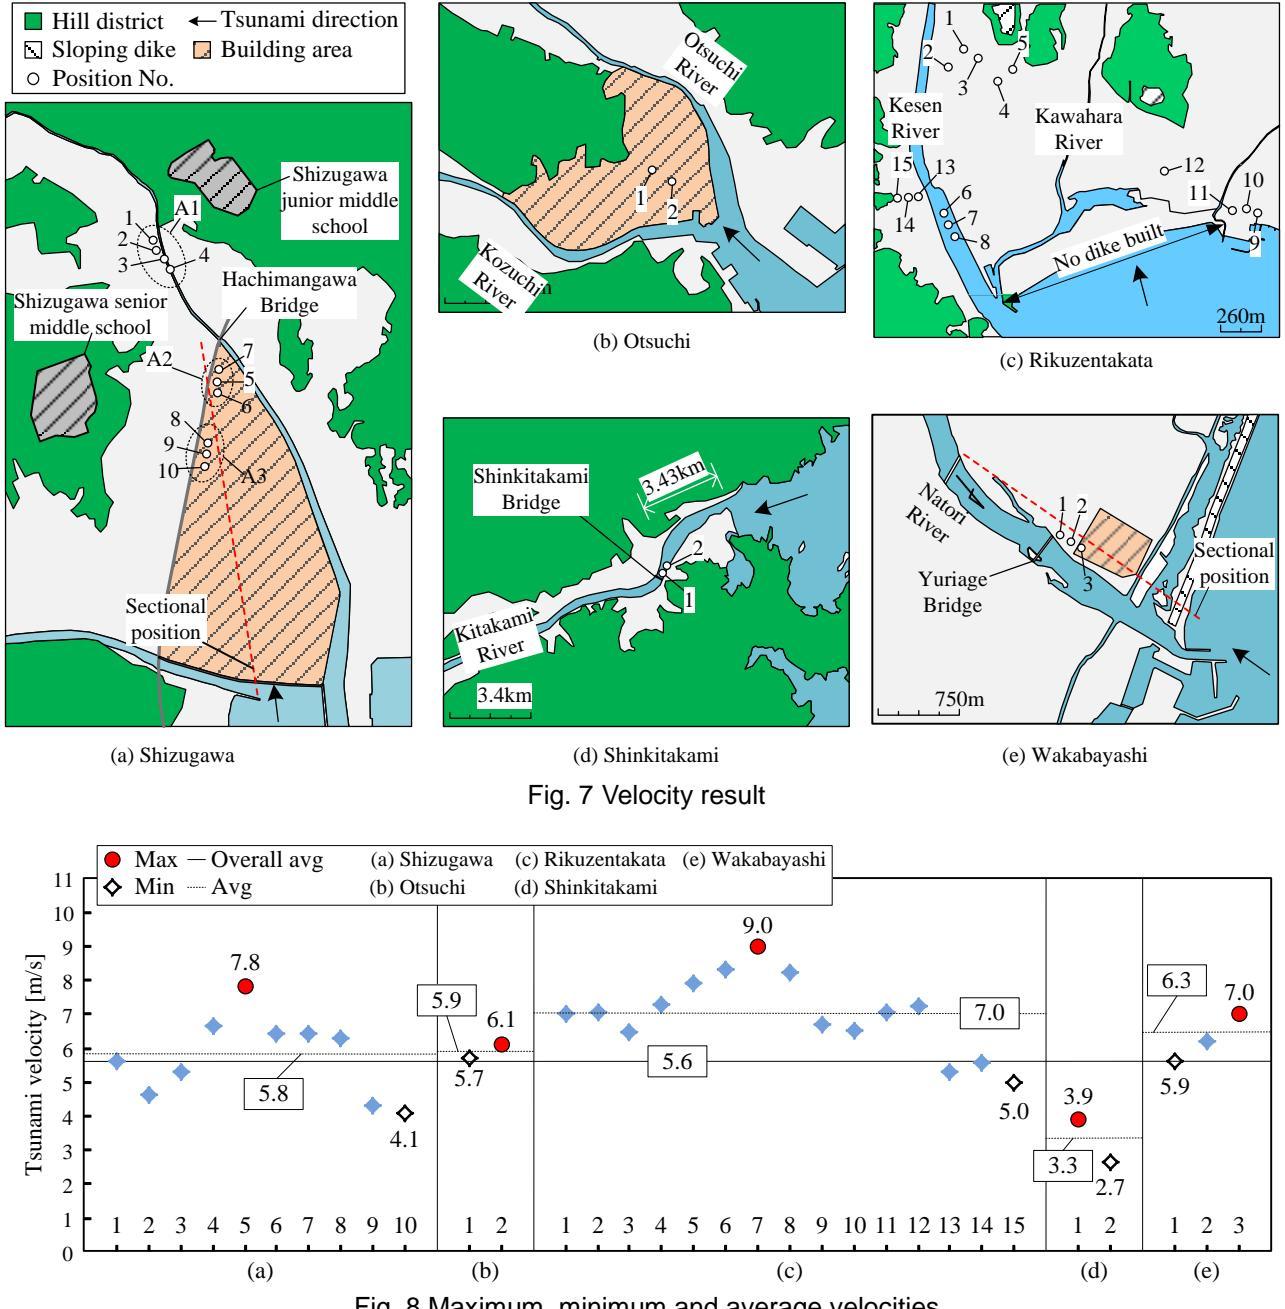
Fig. 8 Maximum, minimum and average velocities

By the same process, the tsunami velocities in Otsuchi, Rikuzentakata, Shikitakami and Wakabayashi have been estimated and the measure positions are illustrated in Fig. 7-(b) to (e). The velocities of each measure position and the average velocity in each area are given in Fig. 8. The overall average is 5.6m/s. It is obvious that the average velocities in Shizugawa,

Otsuchi and Wakabayashi have the same level (about 6.0m/s) and are close to the overall average. In addition, the average velocities in Rikuzentakata is greater while in Shinkitakami is smaller than Shizugawa. The velocity in Rikuzentakata change greatly in different positions as well as Shizugawa and it is common that in different measure positions, the velocities have 0~50% difference from the overall average velocity.

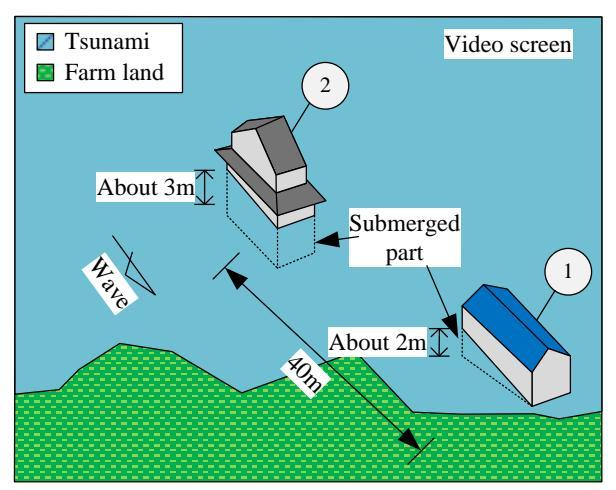
Fig. 9 Estimate of tsunami height

Fig. 9 plots the video screen recording the front part of wave in Wakabayshi. From video, the shape and height of forward wave is outlined. Further, by checking the inundation depth^[3] (T.P), the maximum wave height at coastal line is confirmed smaller than 10m (as shown at the coastal line in Fig. 10-(a)). In this way, the tsunami sectional Fig. 10-(a) in Wakabayshi was plotted (sectional position listed in Fig. 7-(a)). By the same method, the tsunami sectional figure of Shizugawa is obtained (Fig. 10-(b), sectional position in Fig. 7-(e)). As a result, the waves are able to be simplified as triangle wave, as shown in Fig. 11. The angles of forward wave (γ_1, γ_2) are much smaller than 1° and this demonstrated the 2 waves possibly have the same shape. Thus on the premise of similar wave barrier condition (buildings mainly), the tsunami velocities in 2 areas show the similar level.
