STUDY OF LOW-RISE RC BUILDINGS WITH RELATIVELY HIGH SEISMIC CAPACITY DAMAGED BY GREAT EAST JAPAN EARTHQUAKE 2011

Hamood ALWASHALI*¹, Kazuki SUZUKI*¹, Kanako TAKAHASHI*¹ and Masaki MAEDA*²

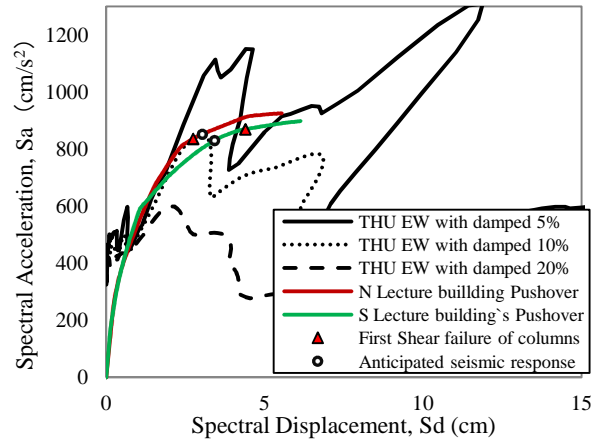
Fig.9 THU EW response spectrum

The response spectra curve of THU EW has low values and sharp peaks at short periods as shown in

Fig.9 and intersects the capacity curve of both buildings at low S_a values. If the capacity method is used, the seismic response for both buildings was expected in the elastic region and that contradicts the actual damage observed in the buildings. Therefore anticipated seismic response was chosen at the point where the actual damage observed relatively matched the damage calculated by pushover analysis which was at relative story drift angle of about 1/200rad in the 1st story for both buildings.

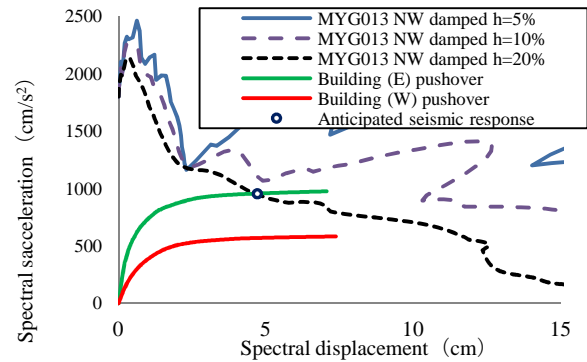
Fig.20 MYG013 NW response spectrum and pushover curves

Two Response spectra, MYG013 KNET and JMA Sendai, are used for analysis. Using MYG013 response spectra, Fig. 20, it is demonstrated that more significant structural damage would occur in building (E) and a higher probability of collapse for building (W). In the other hand, the damage expected using JMA Sendai Spectra, Fig. 21, relatively matches the actual damage.

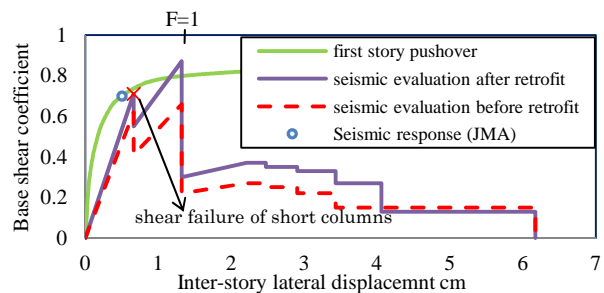
Fig22. Comparison between 1st story pushover and seismic evaluation results of building (E)

I_s index for both buildings are chosen at a ductility greater than $F=0.8$, which means that the failure of extremely short columns was allowed in the seismic evaluation, since axial loads could be redistributed to other columns and the building will not collapse. However, short column failed only in building (W) and didn't in building (E). This is due to several reasons; The $C_{TU} \cdot S_D$ for 1st story at ductility index $F = 0.8$ for building (E) is about twice of building (W), as shown in Table 5. It is thought that building (E) had a story drift just less than $F=0.8$. This is shown using seismic response of JMA NW which is just before the shear failure of short columns (see Fig. 22). Therefore short columns didn't reach their maximum allowable ductility and escaped shear failure. In the other hand, The I_s value for building (W) depends on ductility ($F=1.75$) to reach the criteria of $I_s > 0.7$. The anticipated seismic response using either JMA NW or MYG013NW spectrum are greater than $F=1$ (see Fig.23). At this seismic response, all short and shear columns had shear failure.
