SHEAR FATIGUE PERFORMANCE AND CRACK SURFACE OBSERVATIONS IN PVA-ECC BEAMS WITHOUT WEB REINFORCEMENT

ABSTRACT

Keywords: shear fatigue, reduced fatigue life, fiber damage, smooth crack

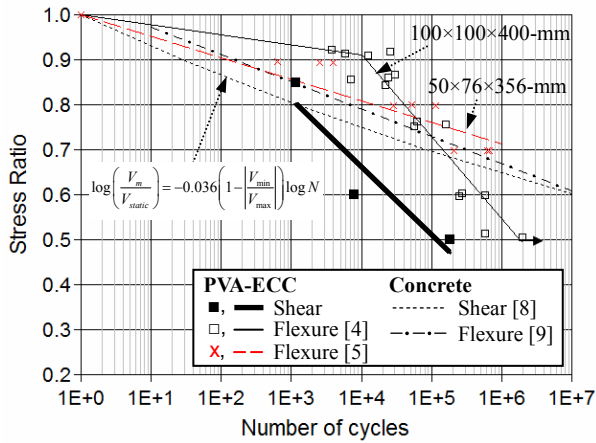
The relationship between loading amplitude S and fatigue life N for the three beams is shown in Fig. 3. From this limited test data, it appears that the S-N curve for PVA-ECC under shear fatigue decreases linearly with log of the number of cycles. The S-N curve does not converge to the ordinate of S at a value of 1.0. Fatigue limit, if such exists, has not been observed.

Plotted also in Figure 3 are S-N curves for PVA-ECC under flexural loading by Matsumoto *et al* [4] and Qian *et al* [5]. The comparison indicates that shear fatigue results in a more rapid breakdown in the properties of the PVA-ECC than does flexural fatigue. It also indicates that the S-N curve for shear fatigue is in a comparable slope to that from Reference [4] and approximately one to one-and-a-half orders lower. Compared to the data from Reference [5], the shear fatigue life is one order lower at S 0.8 and more than two orders lower at S lower than 0.7.

Figure 3 also shows two S-N curves for concrete. The first curve relates to shear fatigue for concrete beam without web reinforcement proposed by Ueda [8].

Fig.3 Shear fatigue life of PVA-ECC under three different constant load amplitudes

The load amplitude V_{min}/V_{max} is set at 0.125. The second curve relates to flexural fatigue for plain concrete, averaged from eight experiments by Lee and Barr [9].

With respect to the stress amplitude S , PVA-ECC appears to exhibit a better fatigue performance than concrete at higher stress amplitudes than 0.8 (shear) and 0.75 (flexure), and worst at lower stress amplitudes. The indication is that lower stress amplitudes are associated with a large number of cycles and crack reversals that introduce more damage to the PVA-ECC.

Considering the different material types, it is observed in Fig. 3 that while flexural and shear fatigue in concrete is somewhat identical, they differ quite significantly in PVA-ECC. In concrete, both flexural and shear fatigue generally depend on the rate of crack propagation. The similarity suggests that the rate, which is generally dictated by the area of concrete being compressed above the propagated crack, is comparable. To investigate the mechanisms of shear fatigue in PVA-ECC, next sections focus on the response and the cracks developed in the test beams.

- (1) S-N curve for PVA-ECC beams without web reinforcement appears to be linear in a semi-log plot at S ranging between 0.50 and 0.85. This line does not converge to S equals to 1.0. Fatigue limit is not observed within the range of S considered.

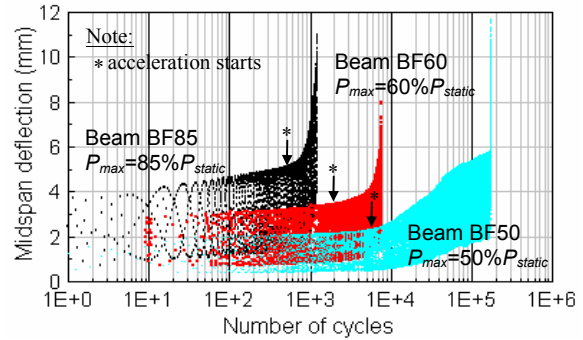
The progress of the midspan deflection of each beam is shown in Fig. 4. It appears that higher load levels result in larger deflection amplitudes. The midspan deflection steadily increases and, when reaches a certain value, rapidly increases. The rate of the acceleration is notably different due to variation of the angle of diagonal shear cracks next to loading plate.

Fig.4 Deflection progress of the test beams

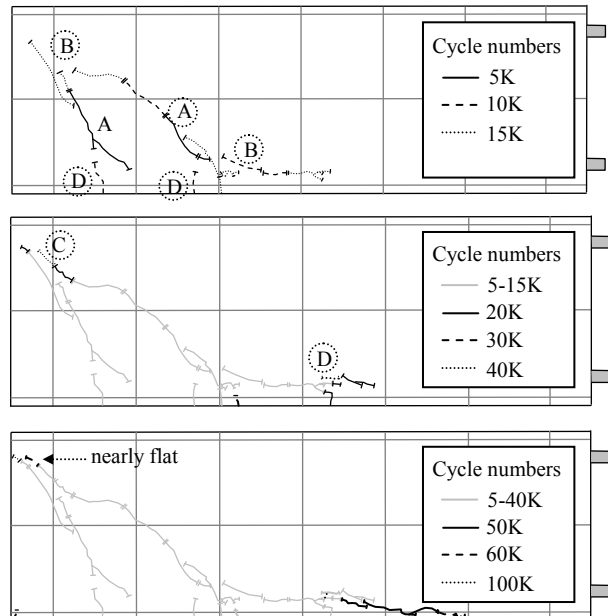
All the three beams exhibited cracking in a very similar way. Figure 5 shows the development of visible cracks in Beam BF50 during the first 100K cycles. Initially, diagonal shear multiple cracks formed, but they were hardly visible. Under repeated loading, these cracks alternately opened, closed, and slip. After approximately 80, 600, and 5K cycles (Beam BF85, BF60, and BF50, respectively), only two to four predominant diagonal shear cracks were visible at an angle of about 40 to 50° around the mid-high of each web region of each beam (see Note A in Fig. 5). The tip of these cracks then propagated towards support and loading plates as the loading further progressed (see Note B). The crack propagation to the loading plate

Fig.5 Development of visible cracks in Beam BF50

occurred earlier, yet it was later arrested when it came close to the bottom of compression rebars (see Note C). The diagonal shear cracks, when propagated toward the support, merged with the pre-existing flexural cracks (see Note D). Where they merged, it was observed that the deformation was mainly carried by dowel of the two tensile rebars, particularly at the flexural crack D.

Figure 5 shows the crack pattern of the test beams after failure. All beams exhibited diagonal shear cracks formed predominantly at angles of between 30° and 50° with respect to the longitudinal direction toward the loading point. In Beam BS, they were uniformly spaced at about 10 mm. The diagonal shear cracks in Beam BF85 distributed in a wider area, with a spacing of about 25 mm. The average crack spacing in Beam BF60 was about 30 mm. In all cases, the predominant shear crack formed at an angle of about 45°. Overall, the number of diagonal shear crack decreased with decreasing load magnitude.

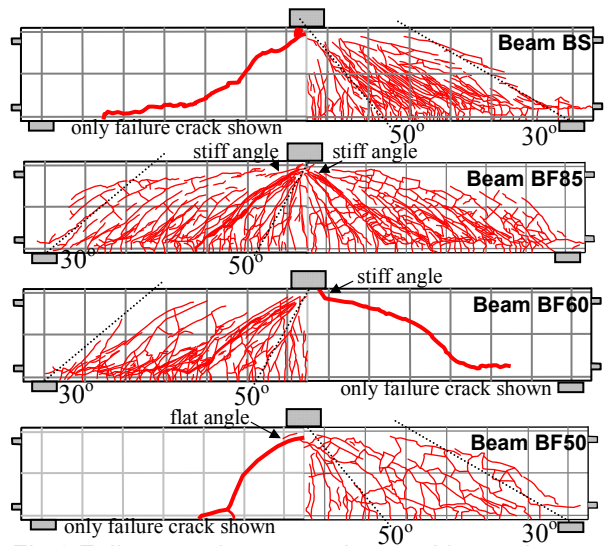
Fig.6 Failure crack pattern observed in test beams

The failure of the Beams BF85 and BF60 were due to the penetration of one diagonal shear crack to the upper surface of the beam next to the loading plate (see Fig. 6). In Beam BF50, the tip of the diagonal crack when approached the loading plate was nearly flat. As a result, this beam tended to exhibit a longer fatigue life for this particular load level. Beam BF50 failed once the two diagonal shear cracks from both sides of the beam merged and one of the tensile rebars fractured.

- (3) Although the number of multiple cracks decreased with decreasing loading amplitude, the visible diagonal shear cracks appeared identical regardless the maximum load levels. It involved the formation of two to four predominant cracks at the web of the beam and their propagation to both support and loading plates. Failure occurred when the diagonal cracks propagated outward, adjacent to the loading plate, or merged with other diagonal cracks from another side of the beam. Failure was delayed when the tip of the diagonal crack nearby the loading plate was nearly flat.

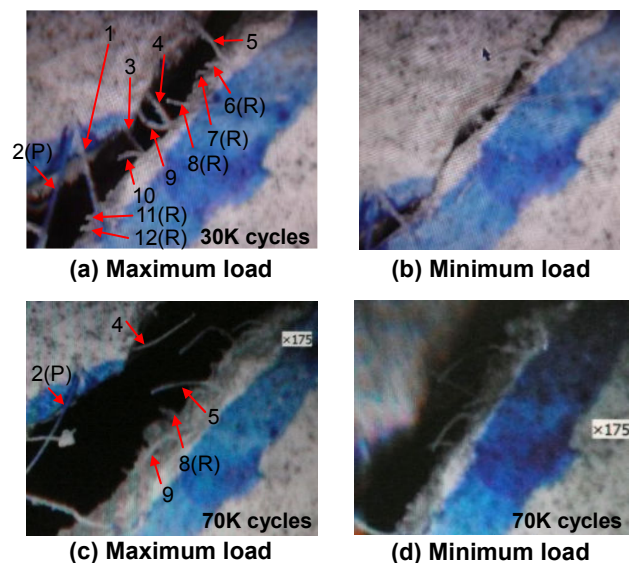
Figure 8 (a) and (b) depicts the behavior of 5-mm long diagonal shear crack at the mid-high of the beam at 30K cycles. As one would expect, the crack was under mixed mode deformations. The crack open and slide under the maximum loading, with a maximum width of about 1 mm. Under the minimum loading, the two crack surfaces closed and rubbed over each other. Twelve PVA fibers were identified. Fibers 1, 3, 4, 5, 9 were bridging the two crack surface. Fibers 6, 7, 8, 10, 11, and 12 had already ruptured, while Fiber 2 had been pulled out because it was on the surface and hence should be neglected. All fibers were compressed and rubbed by the two crack surfaces during crack closure.

At 70K cycles [see Fig. 8(c) and (d)], it was observed that only Fibers 4, 5, 8, and 9 remained, and the crack did not completely close under the minimum loading. This suggests that there was a transition in the dominating shear fatigue damage. At low cycles, damage accumulated due to crack closure and slip that broke the fibers at diagonal shear cracks. At high load cycles, this mode did not contribute anymore and the damage is attributed by the propagation of cracks occurring at the tip of diagonal shear cracks nearby to the loading plate at midspan.

Fig.8 Diagonal shear crack response at (a), (b) 30K cycles, (c) and (d) 70K cycles

To gain deeper insights into the behavior of shear cracks, additional visual observations were made in Beam BF50 during repeated loading. Two scanned locations were determined, one at the mid-high of the beam, and the other one at the region nearby the bottom rebars.
