- Technical Paper -

EVALUATION OF RE-CURING FOR THE RECOVERY OF HIGH-STRENGTH MORTAR EXPOSED TO FIRE

Michael HENRY^{*1}, Tae-Ho AHN^{*2}, Yoshitaka KATO^{*3} and Toshiharu KISHI^{*4}

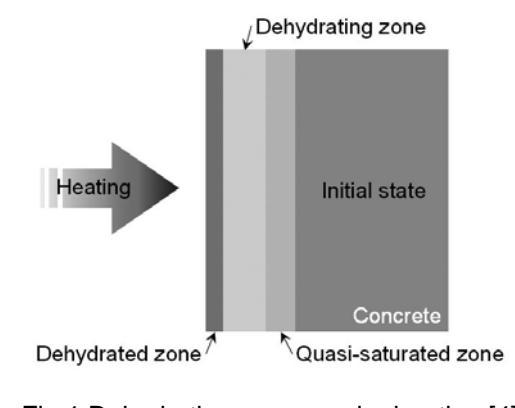
The progress of dehydration of the cement paste, which depends on the temperature gradient, has a direct bearing on the re-curing behavior (Fig. 1). The dehydrated zone is a brittle layer composed of sintered material which cannot undergo re-curing. The dehydrating zone is the region in which evaporation of free water and chemically-bound water is occurring, but the material has not yet been sintered. The quasi-saturated zone contains water under heating. Re-curing is most likely to be effective in the dehydrating zone, where supply of water can both rehydrate dehydrated cement, as well as hydrate unhydrated cement [5]. In the quasi-saturated and initial state zones, supply of water would serve primarily to hydrate the unhydrated cement grains which are found in high strength, low water-cement (W/C) ratio concretes. By supplying water and initiating the hydration reaction, hydration products fill the pore space and reduce porosity. Since porosity is a primary factor for determining strength and durability, a reduction in porosity should correspond with an increase in these properties.

Fire exposure was emulated using an electric furnace. As this furnace does not have a control mechanism for the rate of heat increase, the furnace was preheated to the target temperature before beginning exposure. The temperature was set at 550°C for this experimental program. This value was chosen by performing a trial series of tests in order to determine, for this specimen shape, size and mix proportions, the temperature at which the amount of fire damage was the highest yet the probability of spalling the lowest. A 2-hour exposure time was also selected based on a trial experimental series. This exposure condition was assumed to yield complete dehydration at the surface, with a profile similar to Figure 1.

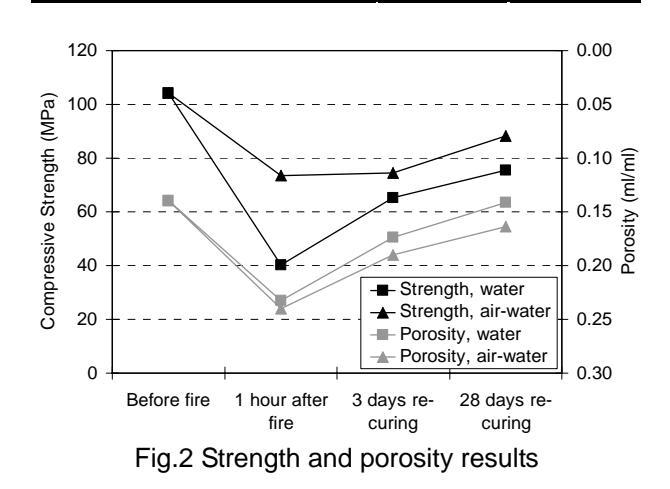
Strength and porosity results are shown in Figure 2 for water and air-water re-cured specimens. By 28 days, water and air-water specimens recovered to 72.4% and 84.5% of their pre-fired strength, respectively. Water specimens underwent a strength loss of 61.5% but recovered 33.9%; air-water specimens lost 29.5% and recovered 14.0%. The effect of thermal shock on strength can be observed in the 33.4% difference in strength 1 hour after the fire.

Porosity loss and recovery can also be observed for both re-curing conditions. After heating, porosity increased by 67.1% and 72.7% for water and air-water, respectively. Water specimens recovered 65.4% for a final porosity 1% larger than the original value. Air-water specimens recovered only 55.0% to 17.6% larger than the original porosity. There was no significant thermal shock effect on the porosity, as both series of specimens exhibited nearly the same porosity after 1 hour of cooling.

The strength reduction observed in Figure 2 can be attributed to three factors: porosity (discussed in the previous section), chemical deterioration (not investigated in this research), and cracking. While the relative influence of each of these factors on the strength recovery is not clear, self-healing of cracks was observed under water supply (Figures 6 and 7).

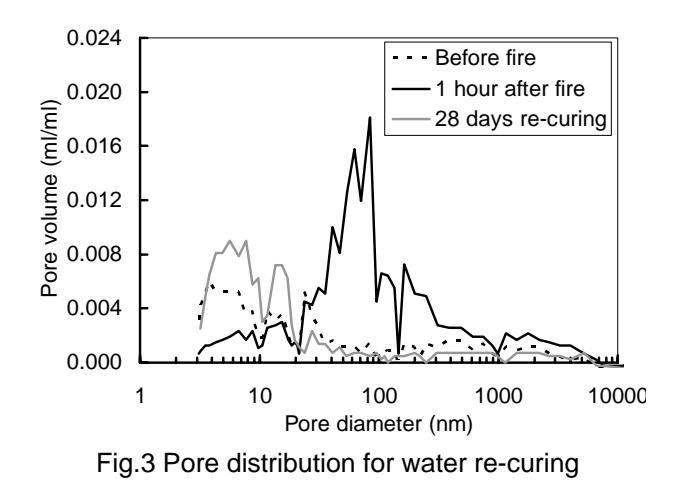
In order to observe the porosity behavior in greater detail, the pore distributions before heating, after heating, and after 28 days re-curing are shown in Figure 3 for water specimens and Figure 4 for air-water specimens. 3-day results were omitted for clarity.

Heating caused a significant increase in the average pore size for both water and air-water specimens. Before heating, the pore fraction was concentrated between 3 and 40 nanometers; after heating, between 20 and 1000 nm, with a much larger occupied volume. In both cases, re-curing led to the recovery of the pore structure by 28 days.

The recovery of porosity and the pore structure was shown in Figures 3, 4, and 5. It was shown that, after 28 days re-curing, the distribution of pores for both water and air-water specimens were different than before heating; pores tended to be of a smaller diameter but occupied a greater volume. In order to understand this phenomenon, the source of pore structure recovery should be discussed. It is believed that CaO, produced from the decomposition of CH and $CaCO_3$, as well as calcium silicate compounds, from the decomposition of C-S-H by heating, can be rehydrated by the supply of water after heating exposure [7]. If this were the only source of recovery, the recovered pore structure should be similar in nature to the original. However, as can be seen in the previous figures, the concentration of pore diameters after re-curing is less than before, so some other reaction has taken place to reduce the pore sizes further. Typically, this is attributed to the hydration of unhydrated cement grains in the concrete matrix, and has been mentioned in previous research works.

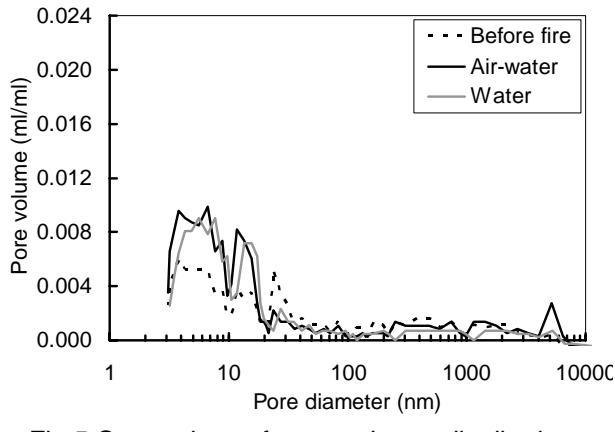
Fig.5 Comparison of re-cured pore distributions after 28 days re-curing

A comparison of the 28-day re-cured pore structures for water and air-water specimens is given in Figure 5. For both water and air-water, re-curing after fire resulted in a greater volume of smaller pores than before heating. However, pores in the water specimens occupy less volume than in air-water specimens. Measurement of the weight of water specimens (1 hour after water submersion) and air-water specimens (1 hour air, 1 hour water) found that water specimens absorbed 44.7 grams of water compared to the 37.5 grams for air-water specimens.

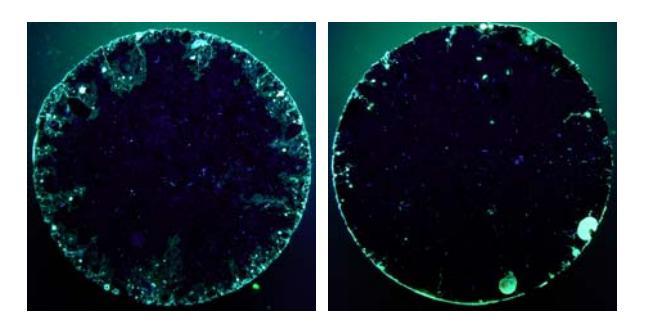
Fig.6 Cracking of water specimen 1 hour after heating (left) and 7 days water re-curing (right)

Cracking of water specimens observed utilizing epoxy injection can be seen in Figure 6. Light areas in the image show where epoxy penetrated through cracks; dark areas are un-cracked, or where epoxy didn't penetrate.

The effect of immediate water submersion is shown in the left figure. The epoxy can be seen in small, spidery radial lines, which indicates the occurrence of micro-cracking. Visual inspection of these specimens showed no visible defects. Almost no epoxy is visible in the right figure, which shows that epoxy was unable to penetrate due to the self-healing of the micro-cracks under water supply.

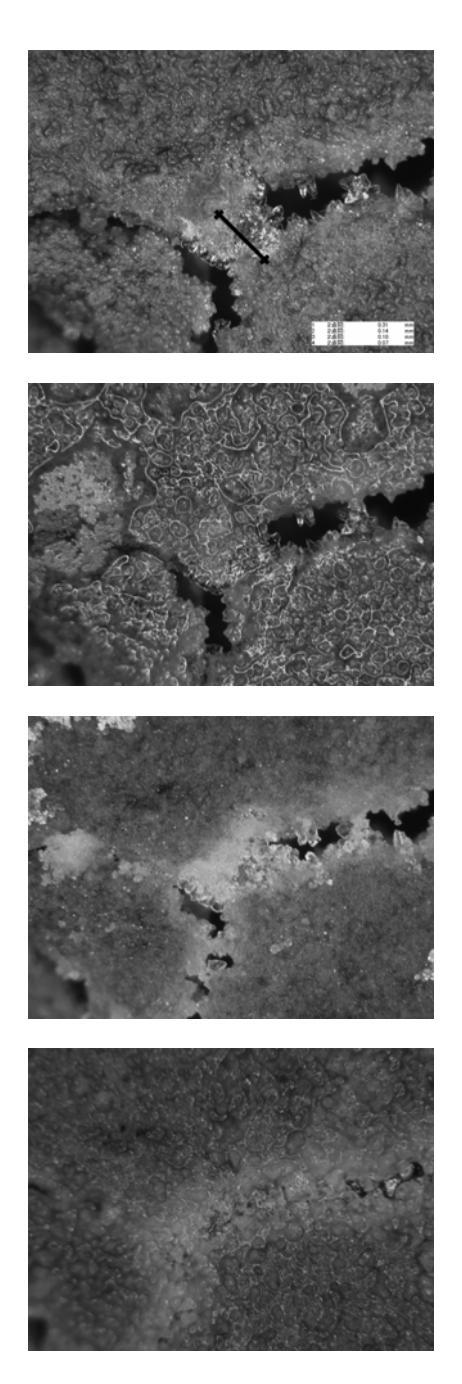
Fig.7 Crack self-healing at (from top) 1 day, 3 days, 7 days, and 28 days

Microscopic observation of crack self-healing under water supply is shown in Figure 7 for 1, 3, 7, and 28 days of water re-curing. Specimens in this case were allowed to air cool until surface cracks formed, and then submerged in water. The initial crack width, marked in the top image, was 0.31 millimeters.

Water re-curing was effective in causing the self-healing of the crack. Significant regrowth could be observed by 7 days, and almost complete self-healing was seen by 28 days.

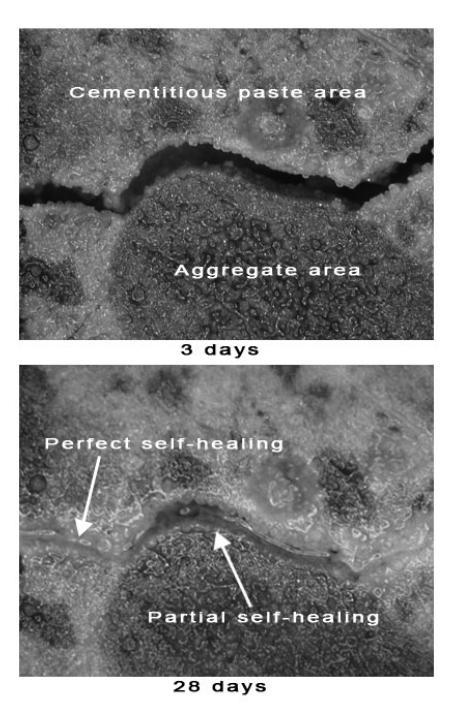
Fig.8 Example of partial self-healing around aggregate in non-fired concrete [10]

Cracking around an aggregate and the self-healing behavior in this area is shown in Figure 8 for non-fired concrete. In the region where both faces of the crack are cement paste, the crack self-healing occurs from both sides, so complete recovery can occur. However, where one side of the crack is aggregate, only partial self-healing behavior was observed. Therefore, while this behavior has not been studied or observed in fire-damaged concrete explicitly, it can be assumed that self-healing around aggregates will occur similar to that of non-fired concrete. As a result, this type of cracking requires special consideration for realizing the potential of re-curing as a recovery method.

- (4) The damage mechanism and self-healing of cracks around aggregates in concrete was conceptually proposed. An example of partial self-healing in non-fired concrete was given to demonstrate the type of behavior that could be expected during re-curing.

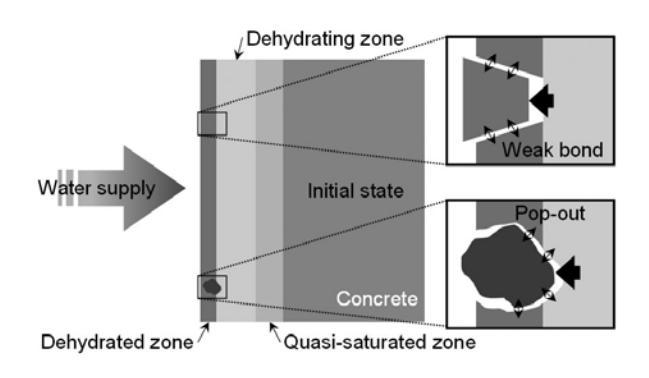
Fig.9 Damage due to expansion of dehydrating zone under water supply

Re-curing, which generally restores strength and durability by reducing porosity and healing cracks, may also cause damage due to the expansion caused by hydration and rehydration. Although mentioned in previous research [9], this concept was not directly related to the concept of dehydration zones. The mechanism is most easily viewed at the surface and around aggregates, where the bond strength after heating is weak. When considering the dehydration zones, shown again in Figure 9, the dehydrated zone can be characterized as a thin, brittle layer of sintered material with no capability for re-curing. However, the dehydrating zone below that can undergo re-curing through hydration and rehydration of unhydrated cement and dehydrated cement, respectively. During re-curing of the dehydrating zone, expansion will occur due to the hydration/rehydration reactions. This will place stresses on the dehydrated zone and may result in a kind of secondary spalling, in which the expansive force breaks the weak bonds of the outer layer and causes the surface layer to break away. While the full extent of this effect is uncertain, it may result in merely an unsightly appearance if the outer layer is thin, or could potentially have a greater effect on mechanical sense or durability if the spalling is deeper.

Aggregates may also cause secondary spalling. As explained in the previous section, cracking occurs around aggregates due to stresses caused by incompatible thermal deformation with the cement paste. If the aggregate is located near the surface, then expansion due to re-curing in the dehydrating zone may cause aggregate pop-out due to the weakened bond between the aggregate and the surrounding paste caused by cracking.

- (5) While re-curing is intended to restore the performance of concrete, expansion under re-curing may destabilize the sintered outer layers, resulting in secondary spalling either as cement flaking or aggregate pop-out. The effect of this damage needs to be studied in order to understand the scale of this damage. One solution may be the development of a chemical bonding agent, which could act to restore bonding in the brittle layer and between aggregates and cement paste.
