- Technical Paper -

# STUDY ON CHLORIDE-INDUCED CORROSION IN POST-TENSIONED CONCRETE BEAMS WITH INSUFFICIENT GROUT CONDITION

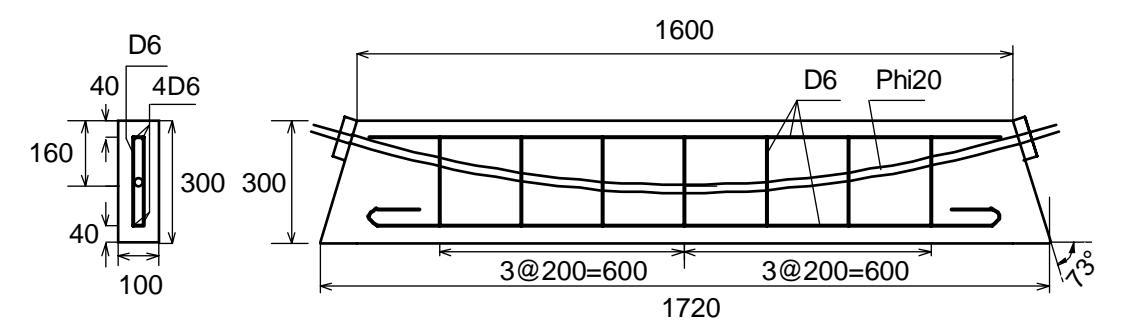
Fig. 1 Details of test beams (series -A) (mm)

Two sets of tests, series-A and series-B, were conducted. The purpose of series-A is to make clear the influence of insufficient grouting in parabolic steel sheath on PC beam corrosion, while series-B is designed to clarify the radial pressure surrounding the tendon during the corrosion process. The details of the test specimens used for series-A is shown in Fig.1. All the beams were provided with 4-D6 (deformed bars 6 mm in diameter) longitudinal bars and 7-D6 stirrups at 200 mm center to center spacing. To avoid the corrosion, the longitudinal bars and stirrups were coated with epoxy resin. A spiral steel sheath with a diameter of 20 mm was used for all specimens. All the beams were cast in the laboratory using high early strength Portland cement with a maximum aggregate size of 20 mm and slump in the range of 100-140 mm. The average compressive strength of concrete was 40 MPa. The prestressing tendons used were of the strand type with a diameter of 9.3 mm and designated SWPR7A in Japan. Their tensile strength was 1720 MPa. All specimens were prestressed with 53.3 kN force corresponding to approximately 60% of the tensile strength of the tendon. After stressing, the tendon was anchored using wedge-type anchorages at each end of the specimen through the steel plate. To avoid corrosion of the steel plate, the area up to 50 mm from each end of the specimen was coated with epoxy resin and a rubber pad was inserted between the steel plate and the specimen itself. After tendon stressing and anchoring, grout (W/C = 45%) was injected into the sheath.

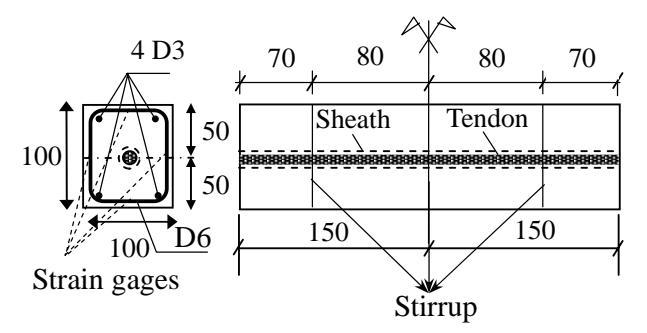
The details of the test specimens used for series-B is shown in Fig.2. All the specimens were provided with 4-D3 (deformed bar 3 mm in diameter) longitudinal bars and 3-D6 stirrups. In this experiment, electrical-resistance strain gages with 2 mm length were used to measure strains of stirrups. Similar to the series-A, the longitudinal bars and stirrups were coated with epoxy resin and the average compressive strength of concrete was 40 MPa. After casting of series-B, spiral steel sheath was removed from the specimen so that only the tendon was used for the accelerated corrosion test. After removing the sheath, grout (W/C = 45%) was applied into the void space until the desired depth of grout was gained.

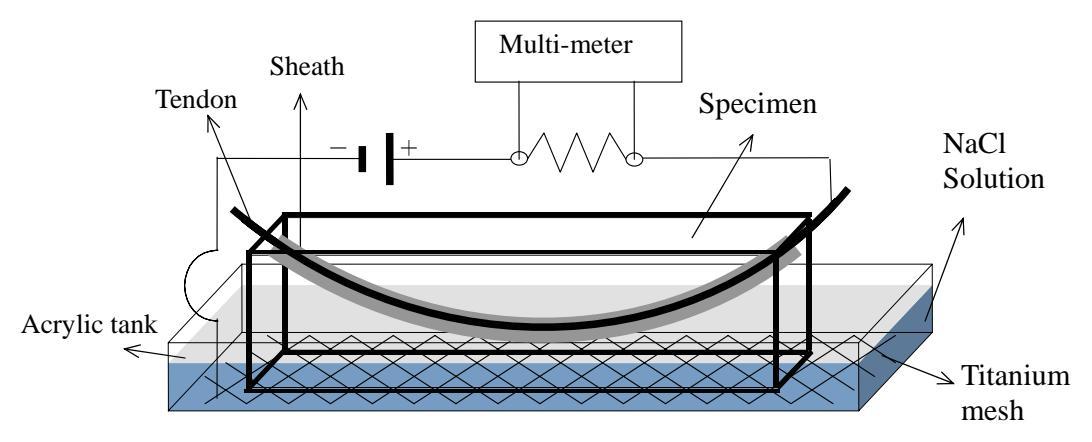
Fig. 3 Test setup for accelerated corrosion testing method (Series-A)

ACTM was adopted to simulate the long-term deterioration of PC beams in a short period. To induce galvanic accelerated corrosion, the specimen was immersed in an acrylic tank containing 5% sodium chloride solution as an electrolyte. The prestressing steel in the specimen acted as the anode, while titanium mesh positioned in the bottom of the tank was the cathode. An external direct current was applied by a current source. The test setup for ACTM is shown in Fig.3. The current was kept constant at 0.57 A for the beam series-A and 0.7 A for the beam series-B throughout the tests, which were carried out in a controlled environment at a temperature of 20°C and a relative humidity of 60%. Crack pattern and crack width were monitored during the tests.

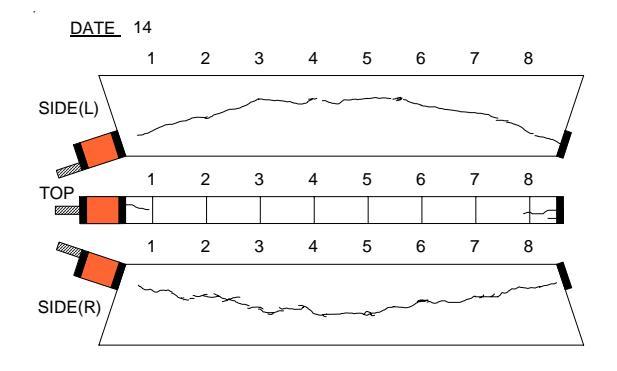
For the series-A beams, cracks occurred in all beams during accelerated corrosion test. Crack occurred after 19 hours of current supply for the beams A3 and A4 while for the beam A2 crack occurred after 34 hours of accelerated corrosion. It means that the corrosion-induced crack in the grouted beam tended to occur earlier than that in un-bonded ones. Figure 4 shows the crack patterns of the beam A4 after two weeks of accelerated corrosion. The corrosion crack occurred and propagated along the tendon level during the corrosion process. During testing, crack width was measured at 8 different points, distributed at equal 20 cm intervals, along the beam. The relationship between average crack width at different points and accelerated time for beams A2, A3 and A4 are shown in Fig.5, Fig.6 and Fig.7, respectively. In beams A2 and A3, the crack width increased from the center to both ends of the specimen. The reason is due to the different lengths of the grout filled inside the parabolic sheath.

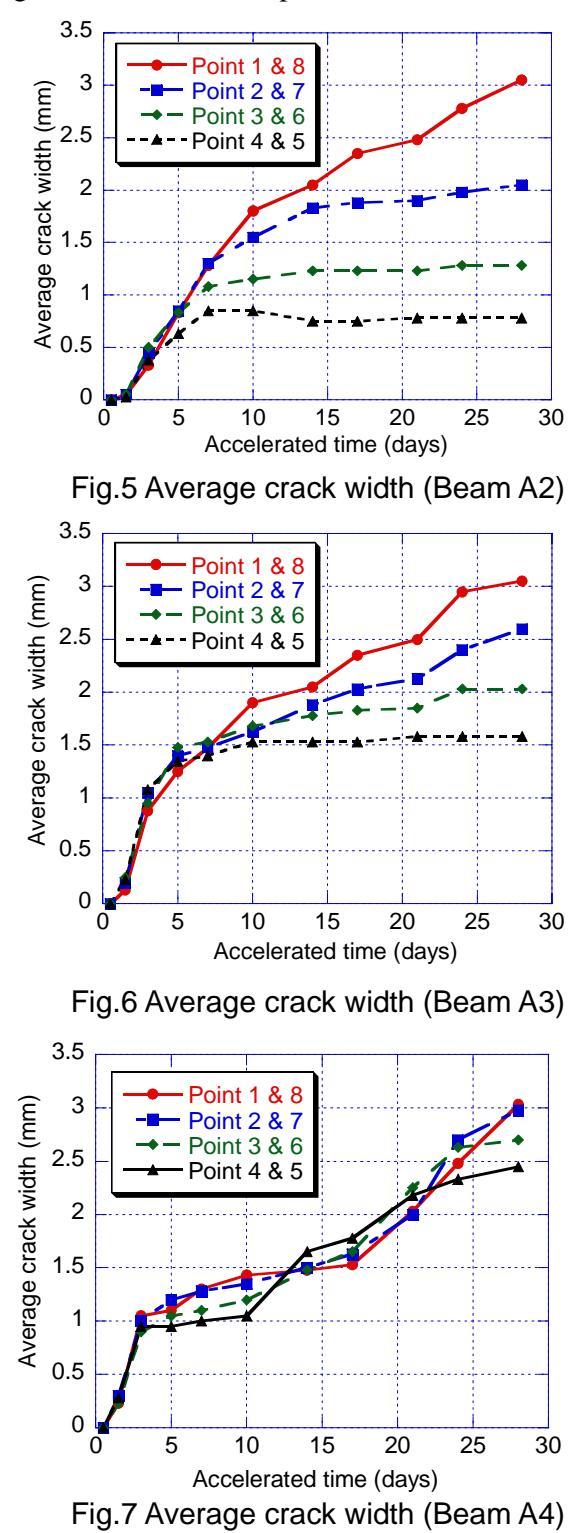
In beam A4, the crack width was almost the same in all points since grout was filled 100% for this specimen. The cracks widened with increasing time in all cases. However, a large quantity of the corrosion product came

out through the cracks near the center of parabolic sheath resulting in smaller crack width at this location as compared to the location near both ends of the beam.

Figure 8 shows the reduction of stress in tendon for series-A beams. The reduction of stress in tendons for the un-bonded beam A2 (L0) was faster than that of the beams A3 (L50) and A4 (L100). That is, the tendon stress reduces with the decrease in the length of grout filling level inside the parabolic sheath. The reason is due to the acceleration of corrosion process of prestressing tendon in insufficiently grouted beams. The prestressing tendon in the un-bonded beam A2 corroded faster than that of the beams A3 and A4. The maximum reduction of tendon stress was 80% for the un-bonded beam A2. This confirmed that insufficient grout inside parabolic sheath has a significant influence on the reduction of tendon stress in PC beams.

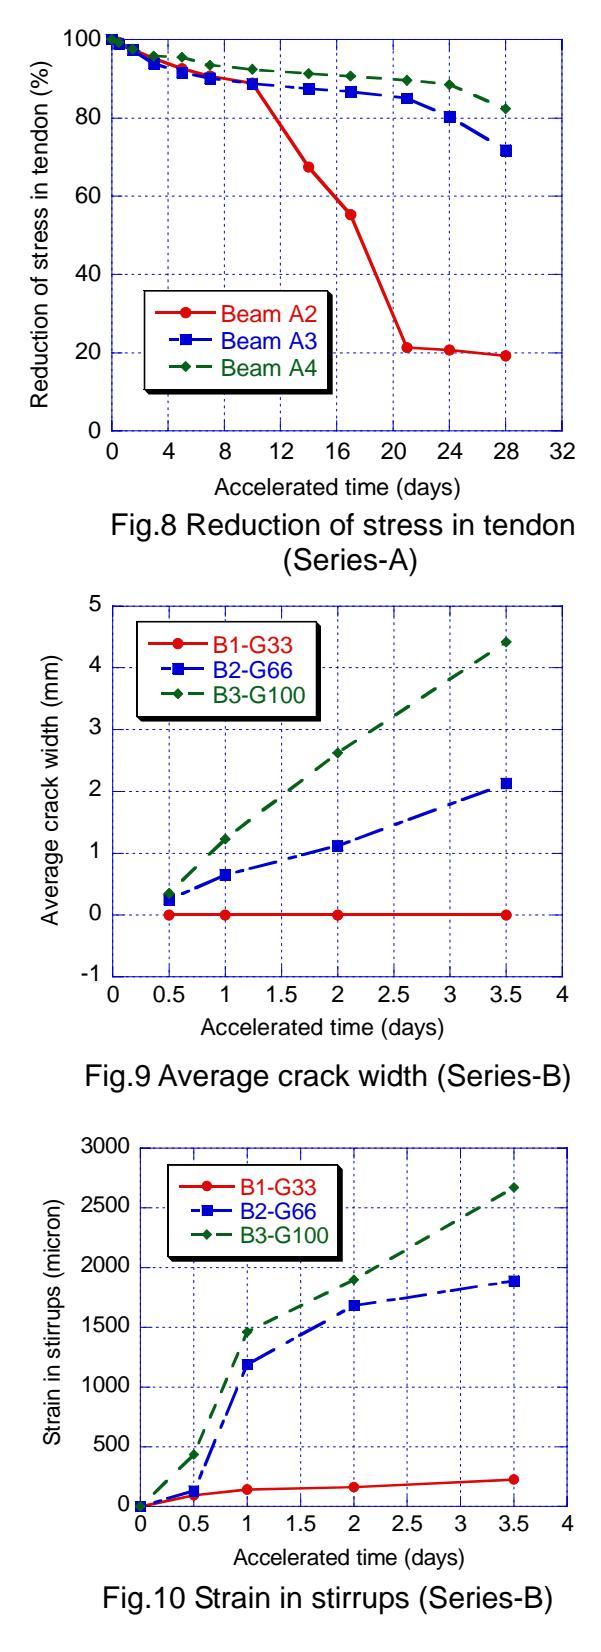
Figure 9 and 10 show the average crack width and strains in stirrups against accelerated time relationships for series-B beams. It shows that the crack width of the beams and strains developed in stirrups increase with the increase in grout filling level. As the tendon corrodes, the volume of corrosion products rises to 2.5 to 3 times the original tendon volume. This increase in volume generates radial expansive pressure on the surrounding concrete, causing cracks to occur. With more grout covering the tendon, the expansive pressure is greater. That is, the radial expansive pressure in an insufficiently grouted specimen is lower than that in a sufficiently grouted one because of the existence of voids in the sheath. This explains why the crack width increases with grout filling level inside the sheath. No corrosion crack occurred in the specimen B1 since the expansive pressure due to tendon corrosion was not sufficient to cause cracking.
